Evaluation of Tsunami Force Acting on Bridge Girders

Synopsis: This paper deals with what tsunami force acted on bridge girders by Great East Japan Earthquake broken out in March 11, 2011. First of all, a lot of efforts were conducted to collect almost all data of bridge girders in the inundation area. Satellite images in internet websites proved very effective to make a quick survey of any bridge in the inundation area. Detailed data on the bridges were obtained from authorities for use in damage analysis. The method proposed by Prof. Kosa was introduced to see whether bridges were washed away or not by tsunami. The resistance of each bridge is expressed as a function of the self-weight of bridge girder, and the tsunami force is defined by hydro-dynamic equation. More than two hundred bridges, including both washed away bridges and survived ones, were analyzed. Motion pictures taken by digital camera during the attack of tsunami were examined to evaluate the velocity and height of tsunami. As far as bridges in a local area were taken into account, the method was good to see whether bridges were survived or not. Field survey of the bridges washed away indicated that the failures w

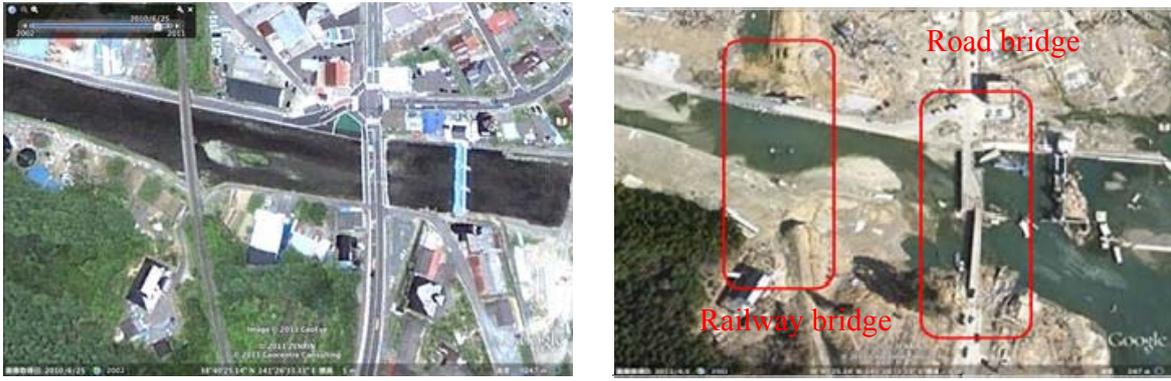
Figure 1. Satellite images.

At the first stage any data of bridges which located in the inundation area from Aomori prefecture in the north to Chiba prefecture in the south were collected by both internet media and on site survey [2]. Fig.1 shows satellite images taken before and after the earthquake.

(a) Before Earthquake (25th June, 2010) (b) After Earthquake (6th April, 2011)

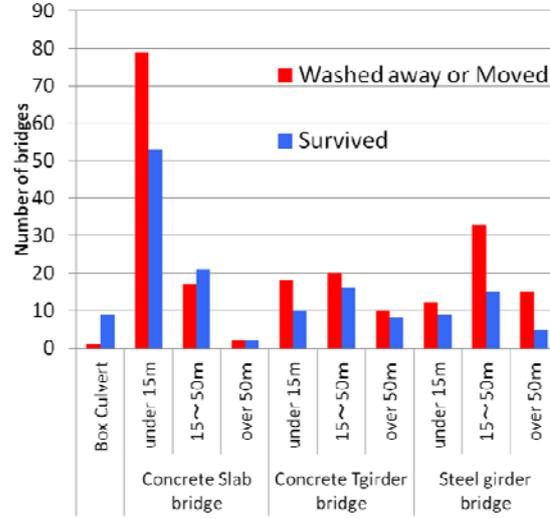
Figure 2: Damage analysis of bridge girders

In order to analyze the damage of bridges, the data of each bridge, such as bridge type (concrete, steel, composite), dimension and structural details were collected from authorities who take care of bridges. Currently, the data of more than 400 bridges are collected and the database is now processed. Using the database, some trials have started to categorize bridges by their types and dimensions to see what a key is for resisting tsunami. Fig.2 shows the number of bridges with or without suffering from washed away in comparison with categorized items, such as type of bridge and bridge length. In the figure, only the survived bridges located near the washed away bridges are selected for comparison. The figure may not give us a clear tendency on what influences the damage of bridge. This is because no consideration is taken for the velocity and the height of tsunami at the location of bridge.

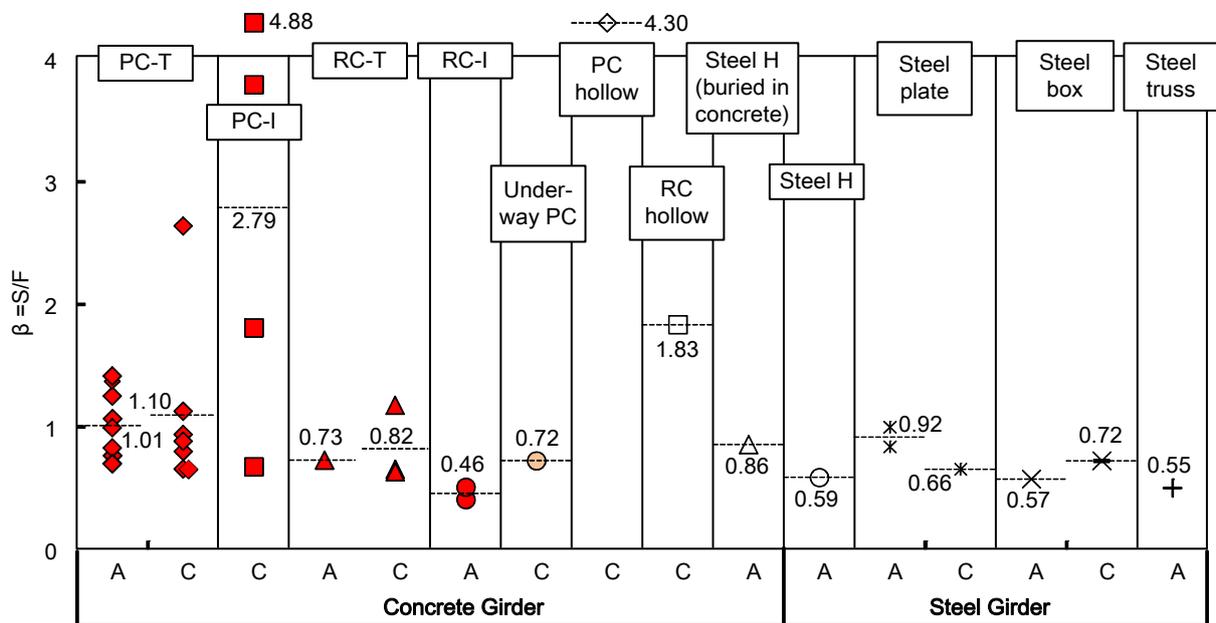
Figure 3: Classification of β by girder type

Fig.3 illustrates the computed β values for 37 different girders. In general, girders having the β value being larger than 1.5 are categorized in Rank C while girders with β being smaller than 0.6 suffered the damage in Rank A.

There observes some girders survived (in Rank C) having β values being less than 1.0. In the previous research works done by Kosa et al. [3]; Zheng et al. [7], obvious differences are recognized in the value of

β for Rank A and Rank C. A variety of types of girders were examined and a general tendency was drowned that those girders having relatively low height and wider width of cross section exhibit higher resistance against tsunami. In addition, the height of pier should play an important role because the velocity of tsunami is a function of tsunami height. In this discussion the tsunami velocity was assumed as 6.0 m/s. Although further development is necessary, the β value defined here could be effective to evaluate how much safe a bridge girder is against tsunami.

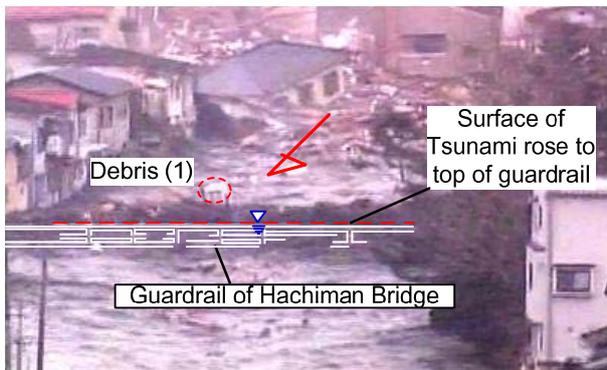
Figure 4. Shot of tsunami wave at Hachiman bridge.

Based on the motion pictures taken by citizens, the characteristics of tsunami in the city are able to be analyzed. Fig.4 shows a picture of Hachiman Bridge in Shizugawa area in Minamisanriku-Chou, Miyagi prefecture cut out from the recorded motion pictures at 7.05 second. A camera was focused on the bridge named Hachiman Bridge. Fig.5 shows the side view of the bridge. In advance of analysis of picture, a key reference height is estimated as follows; (a) the height from the top of guardrail to static water level was 5.7 m, (b) the height from the top of building-(a) to the top of guardrail was 5.9 m, (c) the height from the top of guardrail to the window of building-(a) was about 2.0 m.

The analysis of tsunami is done in such a way that the surface of tsunami reached the top of guardrail at 7:05 second of motion picture, meaning that the tsunami height was 5.7 m. The surface of tsunami reached the window of a house at 7:53 second, meaning that the tsunami height was 7.7 m. Comparing these two sets of data, the rising speed of tsunami can be determined. Motion picture analysis tells that the tsunami height rose with the speed of 3.19 m/min at a time of 4 minutes after the hit of tsunami on Hachiman bridge, and that the tsunami ran up to the maximum 14.8 m high at 7 min. after the hit, at a rising speed of 1.1 m/min. The average rising speed of tsunami height is estimated to be 2.24 m/min. It was relatively low speed, inferring that the wave shape was not the bore type.

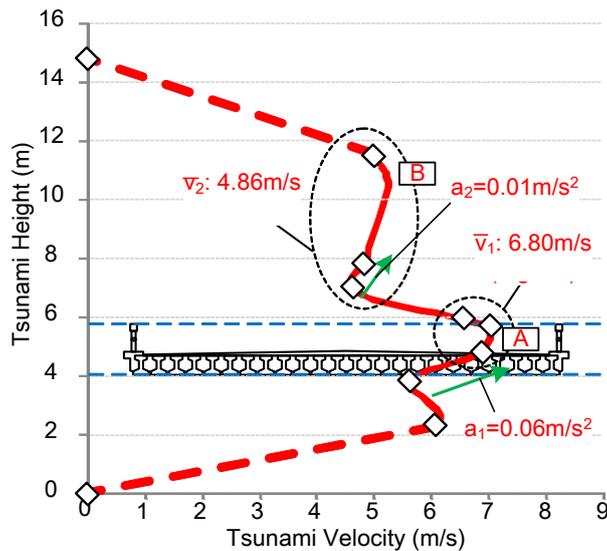
Figure 6. Time-dependent Variation of Tsunami Height.

By the above mentioned process, the wave height and velocity of tsunami can be estimated. Based on the analyzed results the relationship between tsunami height and tsunami velocity is obtained and shown in Fig.6. In the figure the assumption that the velocity should be 0 when the tsunami height is 0 is added. When the tsunami began to fall back, the velocity was treated as 0 as well. Before the tsunami reached about 2m, the tsunami velocity rose to about 6 m/s.

The velocity of tsunami increased continually before the tsunami wave hit the bridge girder. The maximum velocity is estimated as 7.02m/s just before the tsunami wave reached the bridge girder. When the tsunami wave ran up to about 6m high, the bridge girder began to be inundated and the tsunami velocity got to decrease to about 4.86m/s. After the tsunami height reached about 12m, the velocity decreased to 0 gradually.

Fig.6 tells two things. Firstly, the tsunami velocity continuously increases up to the maximum before the tsunami begins to overflow the bridge girder. Secondly, the tsunami velocity decreased suddenly when the bridge girder is inundated. In addition, Hachiman Bridge has a local geographical feature showing that the level of girder is the same as the level of embankment. When the tsunami height rises up to the level of girder, the tsunami would overflow to the land area and that results in the reduction of tsunami energy and velocity.

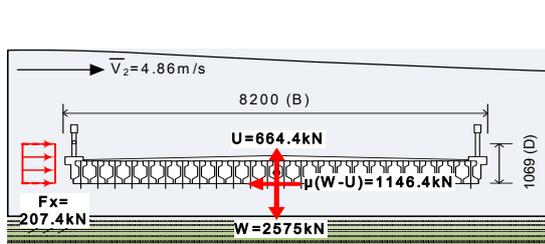
Figure 7. Uniform flow.

Using relatively large water channel which enable to realize 1/10 scale model of bridge girder, the influence of tsunami velocity, water depth as well as existence of solitary wave as shown in Figs.7 and 8 were examined in terms of up-lift force.

The size of water channel was 10 m of width, 4.6m of depth and 50m of length. Two pumps were provided to supply water of 284m³/min. The model scale is 1/10, and on the girders, wave pressure gauges and pour water pressure gauges were installed at 40 locations on the front surface, back surface, top surface, and bottom surface of the girders.

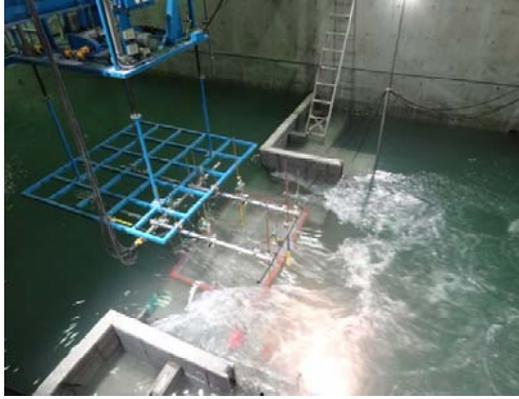
Figure 10. Girder under uniform flow.

Figs. 10 and 11 show pictures of girder in the experiment. In the case of uniform flow (Fig.10) a girder did not move at any water depth or at any water velocity. The similarity rule of experiment indicates that the maximum water velocity in the experiment represents more than 10m/s in the real situation. On the

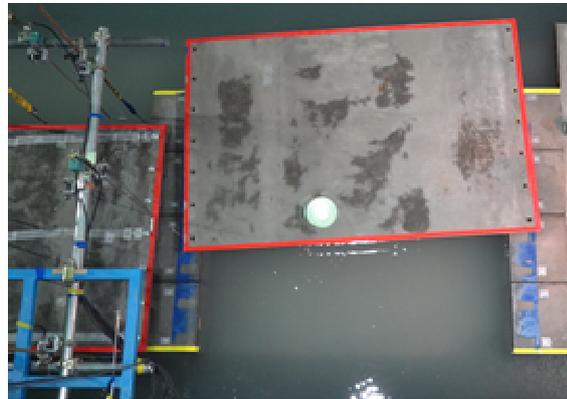
Figure 11. Moved girder under solitary wave.

other hand, the solitary wave could lift and move a girder under certain combinations of water depth and wave height (Fig.11).

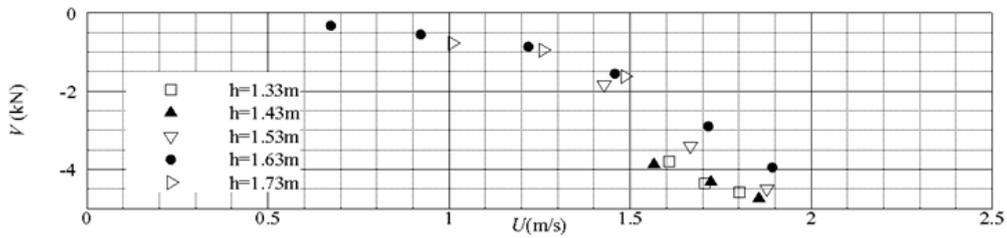
Figure 12. Up-lift force (uniform flow).

Figs. 12 and 13 show the up-lift force calculated based on the measured water pressure. In the case of uniform flow (Fig.12), the up-lift force was measured negative in all cases. That means a girder was pushed downward by water pressure. There was no observation of girder washed away. In the case of solitary wave, a girder was observed washed away in 6 cases. A girder was easy to be washed away when the initial water depth was equal to or less than the girder height and the wave height was large enough to up-lift the girder.

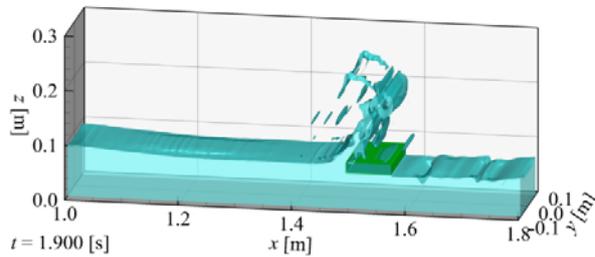
Figure 14. Graphic simulation.

A simulation model has been developed by one of the authors to study experimental results in details [8]. Some figures are shown in Figs. 14 and 15. It needs further development to simulate test results, but this work could give deeper understandings on the mechanism of a bridge washed away by tsunami, and result in proper evaluation of tsunami force in design of bridge.
