Committee Report : JCI- TC072A

Technical Committee on Seismic Resistance of Pilotis Structures and Rigid Frame Viaducts and the Seismic Design (Soft-story Design)

Abstract

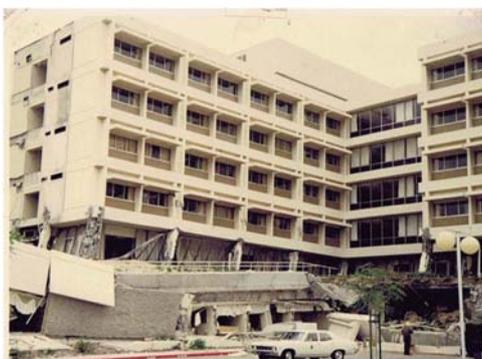
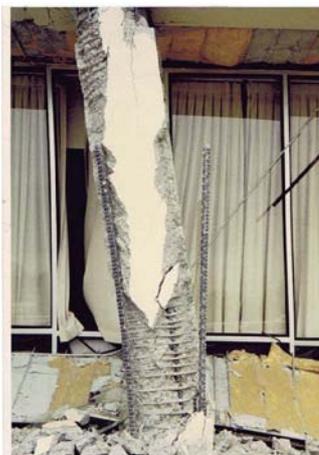
Figure 1.1: State of damage of Olive View Hospital in 1971 and large residual displacement of confined columns on the first story (residual displacement: approx. 50 cm, drift angle: approx. 1/5)¹⁻¹⁾

Success case (Figure 1.1): Olive View Hospital destroyed by the 1971 San Fernando Earthquake. It was a failure in general terms but provided an extremely useful “special solution” – a “soft-story” structure having confined (laterally confined) columns with high deformability on the first layer.

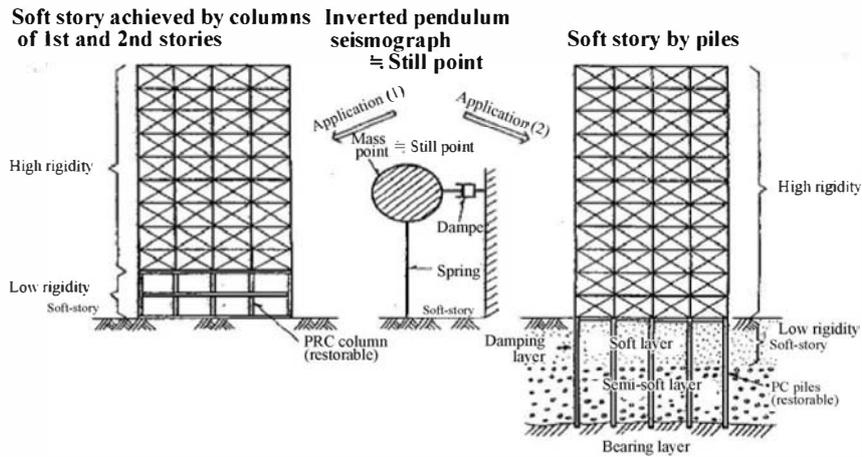
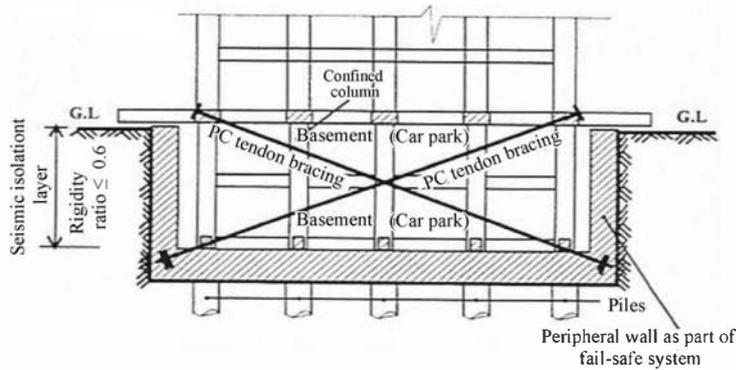
(a) Concept of pilotis story (Soft-story)

(b) A fail-safe technique

Figure 1.2: Concept of pilotis story and application examples¹⁻¹⁾

Policy 2: Figure 1.2 shows an example of a soft story (base-isolated story). If the building has a basement, fail-safe measures can be taken by making the basement serve as a soft story and extending the floor beams of the ground floor to the peripheral walls of the basement. Bracing the basement with prestressing steel also provides high restorability. The damping function should be concentrated on this story.

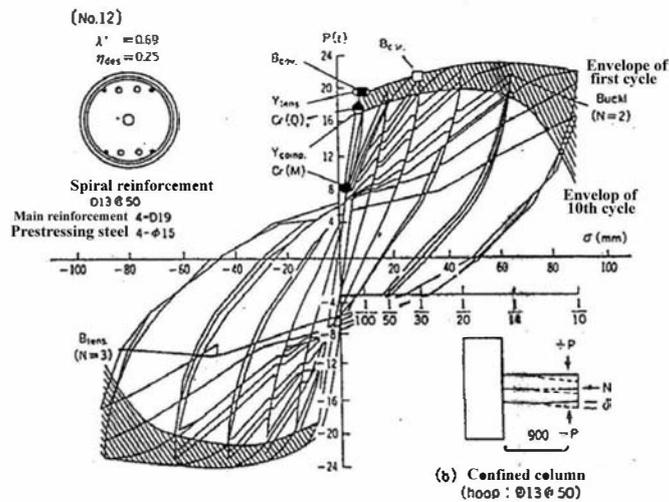
Figure 1.3: Multiple alternate loading test on laterally confined column¹⁻²⁾

Policy 3: The columns of a pilotis story should be sufficiently confined. Such a pilotis story can withstand loads with an inter-story drift (R) of 1/15 to 1/10 repeated some dozen times.

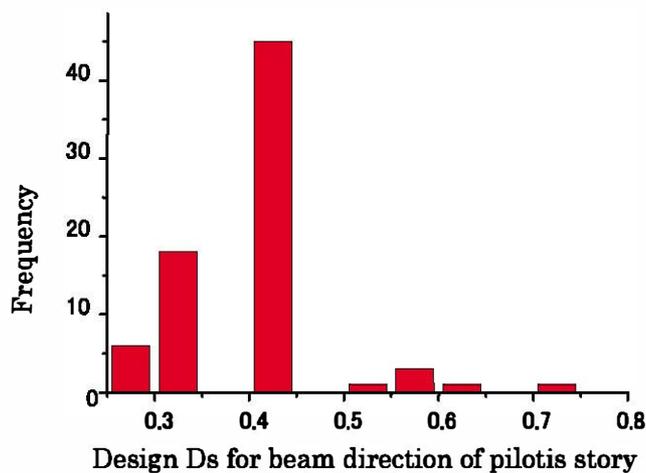
Figure 2.2: Design Ds for beam direction of pilotis story

Figures 2.1 and 2.2 show the histograms of the rigidity modulus of the pilotis story and the D_s for the beam direction design of the pilotis story, respectively. Few buildings have a rigidity modulus of 0.6 or less, suggesting that extras by the rigidity modulus are scarcely adopted in the design practice at the time of this survey.

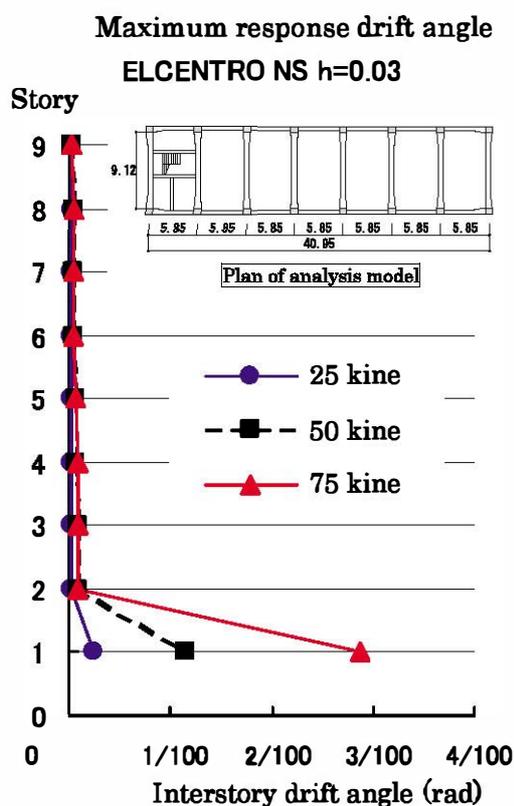
Figure 2.3: Results of seismic response analysis

Using a basic model formulated based on an existing pilotis building (see the figure below), a case study was conducted by seismic response analysis while changing the cross-sectional area of columns and number of walls on the first floor to investigate the properties of pilotis buildings. The results are summarized as follows:

Conclusion: This building is nearly safe against level 1 and level 2 earthquakes. Strengthening of this building by confining columns will ensure safety against level 3 earthquakes (see Figs. 1.2, 3.6, etc.).

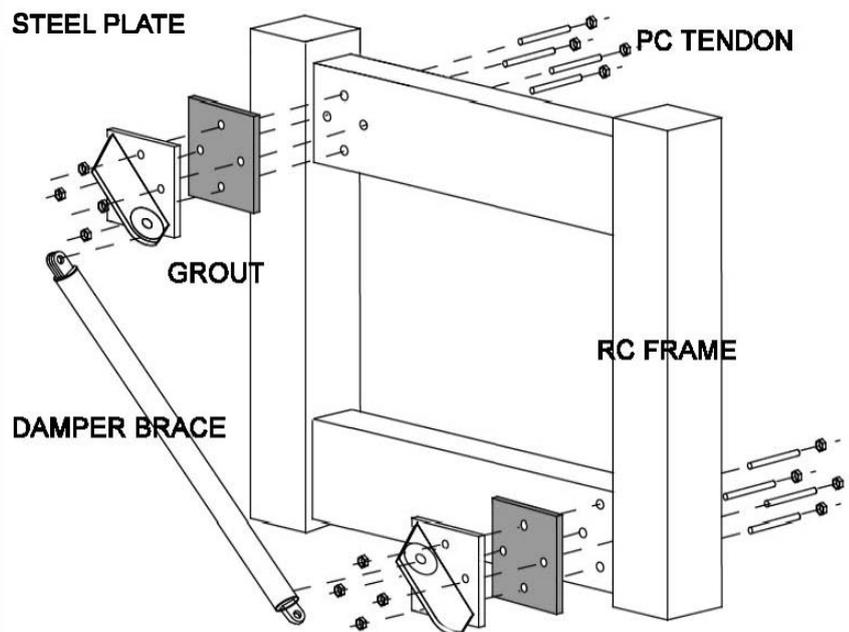
Figure 3.1: External vibration control retrofitting

fixing steel anchorage plates using prestressing steel bars, the work is simple, with a minimum space being occupied by the bracing. The dampers can be dismantled and re-installed when the structural framing requires repair after an earthquake.

This system is applicable to existing reinforced concrete buildings with a high torsional strength and flexural strength of beam ends to minimize losses due to torsional deformation. Buildings in which the axial force cannot be retained after shear failure are out of the application scope of this system. The design of this system is carried out in two stages. In the first stage, the target plasticity ratio of the reinforced concrete structural framing is determined under the earthquake motion for consideration, and the amount of dampers necessary to achieve the target is determined. It is important here to consider the losses in the damper deformation components due to joint weaknesses and the torsional deformation of beams. In the second stage, attachments for the dampers are designed.

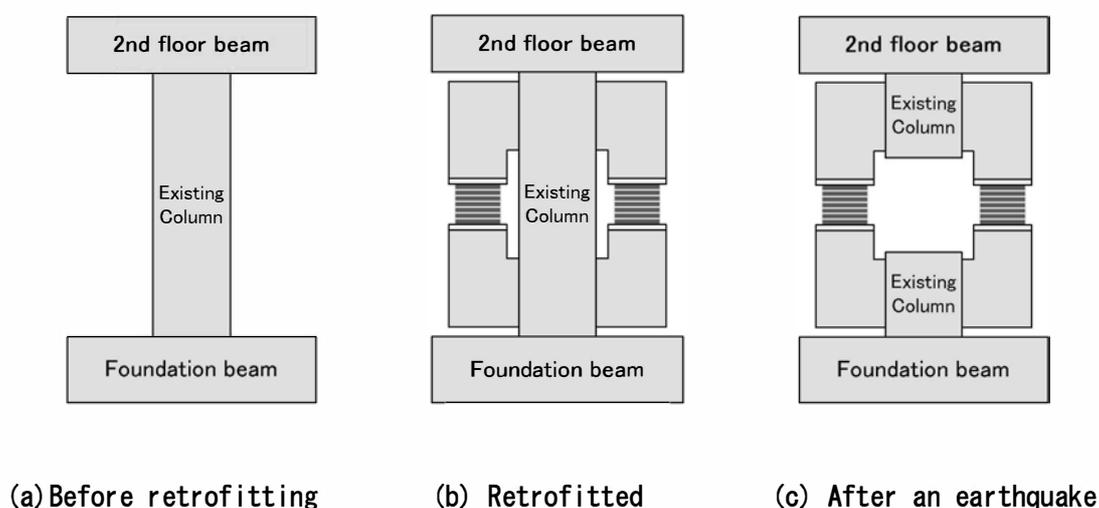
Figure 3.2: Soft-landing isolation system

As shown in Fig. 3.2, this is a system whereby the seismic isolation of a pure pilotis building is achieved by fixing seismic isolation devices to the columns of the pilotis story by compressed connection to positively induce a story collapse in the story. Since this system improves the seismic performance of the entire building, it is effective for buildings where strengthening of the first story leads to insufficient capacities of the upper stories.

For the development of this system, a seismic isolation device was developed that scarcely protrudes from columns, while formulating design guidelines. The relationship between the planar configuration of strengths and distortion was investigated as well. The advantages of this system are that no strengthening of upper stories is necessary and that it permits a two-step investment; it protects human lives as a fail-safe system in the first step and, upon permanent restoration after landing, it initiates its original function of seismic isolation. Subjects of future investigation include the relationship between the order of column failure and the distortion response and seismic isolation of staircases and equipment (to what extent isolation is necessary).

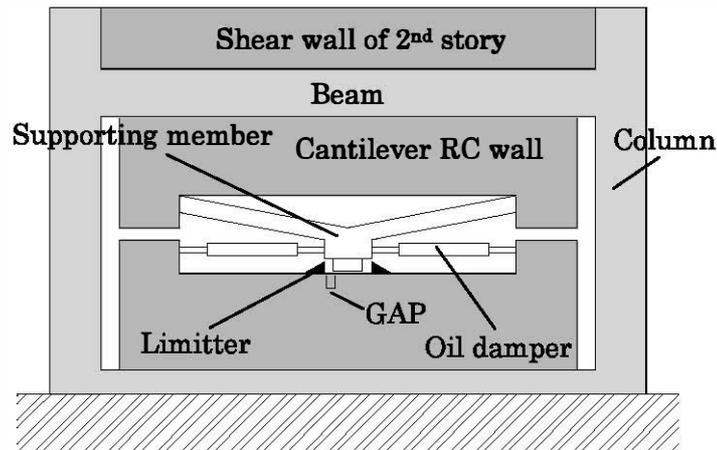
Figure 3.3: Combination of oil dampers and deformation inhibitor

Due to its low rigidity, a pilotis story is subjected to relatively large deformation. Addition of energy-absorbing devices is therefore effective in absorbing energy during a major earthquake without substantially increasing the rigidity of the pilotis story, while reductions in the seismic response similar to base isolation is expected against earthquake motions assumed in the design. Under an earthquake greater than assumed in the design, however, the risk of pilotis story collapse due to the P- Δ effect increases. The use of deformation controllers is therefore effective to be on the safe side. Note that this method is premised on the ductility design/strengthening of pilotis columns, as it requires high deformability of the columns. The Committee proposed two systems using oil dampers and steel dampers (Figs. 3.3 and 3.4, respectively).

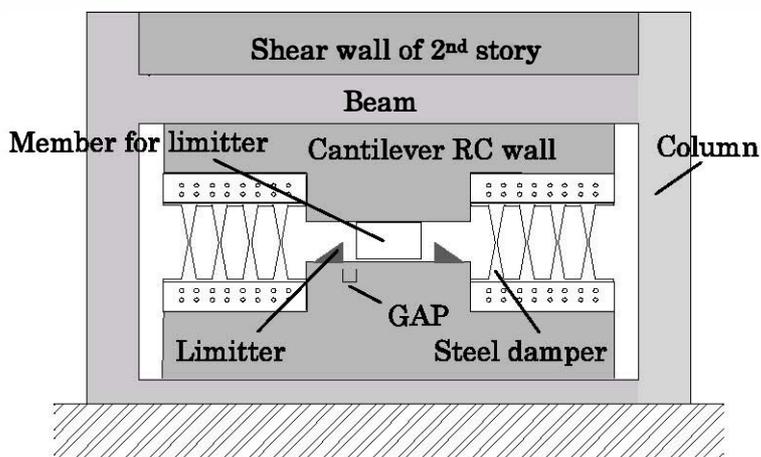
Figure 3.4: Combination of steel damper and deformation inhibitor

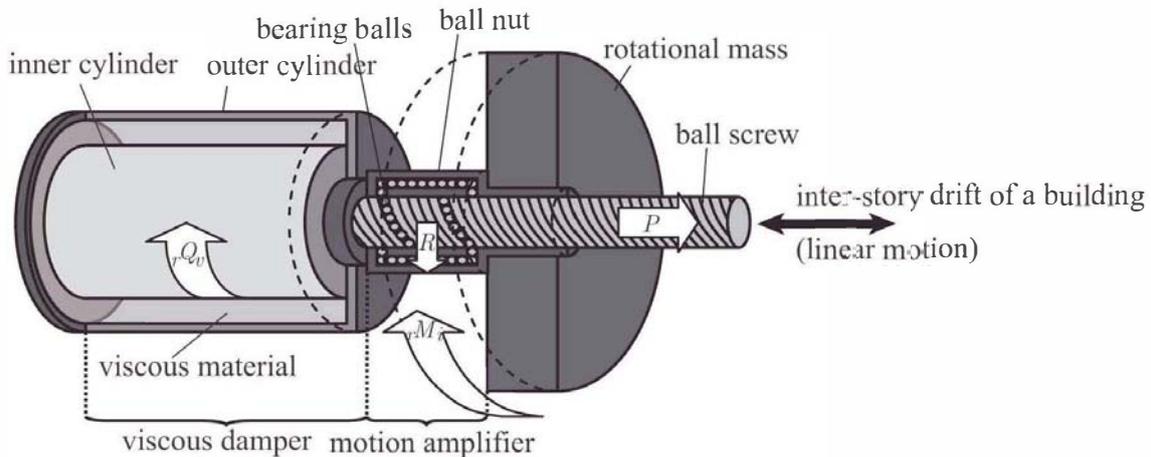
Figure 3.5: Vibration control by viscous tuned mass damper

A new vibration control system has been devised using viscous tuned mass dampers (Fig. 3.5). The Committee proposed a design method using this system for a pilotis story. This system employs an added vibration system tuned with the main structure. The added vibration system comprises equivalent masses, which are amplified by the rotation of the damper axes, and supports. The deformation of the viscous body of the damper is amplified to several times that of the interstory deformation, thereby effectively suppressing the response deformation of the main structure by a small damper amount. It has been proven effective for structures showing elastoplastic properties, such as reinforced concrete structures, provided the system constants are established so that the system is tuned with an equivalent rigidity corresponding to the interstory deformation of a level intended by the design.

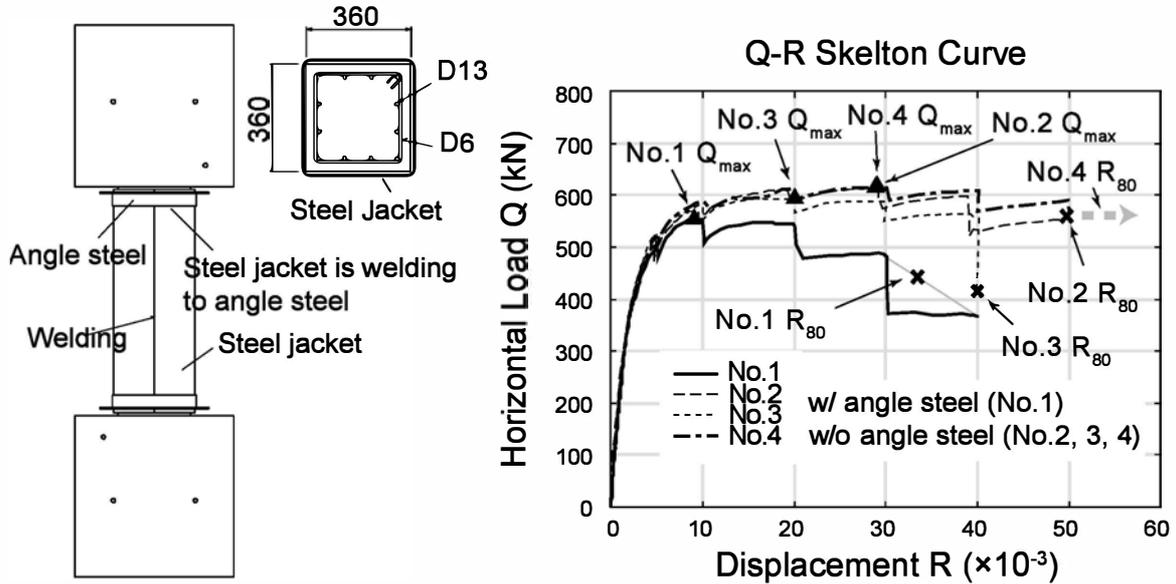
Figure 3.6: Steel jacking with top and bottom confined with angle steel³⁻¹⁾

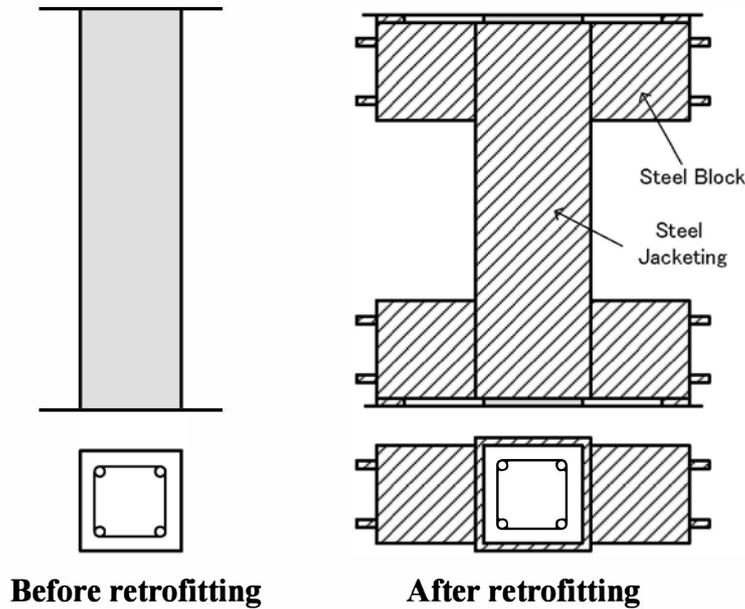
Figure 3.7: Flexural retrofitting using steel blocks

This is a method in which steel blocks are fixed to the top and bottom of a column by compressed connection to increase its effective depth against bending as flexural strengthening (Fig. 3.7). Also, the intermediate portion of the column is jacketed with steel to increase the shear capacity, axial capacity, and flexural ductility. This enhances the flexural capacity, shear capacity, axial capacity, and ductility performance of the column. The advantages of this method include the following: No new reinforcing bars or anchors are necessary; the work is relatively easy; and the capacity estimation is easier than strengthening with wing walls. Future subjects of investigation include the accuracy of shear capacity

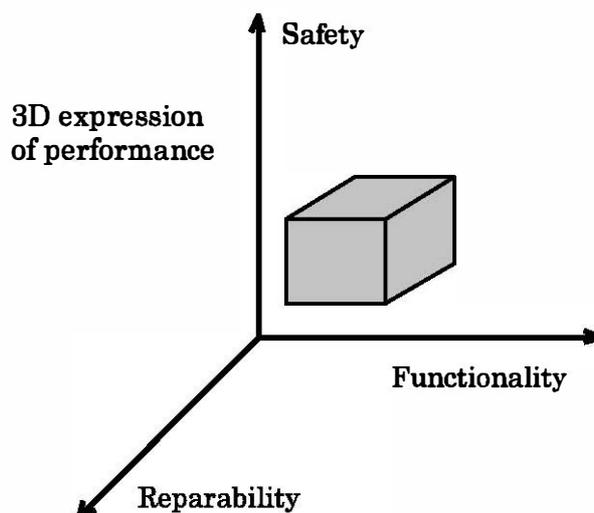
Figure 4.1: 3D expression of reparability performance

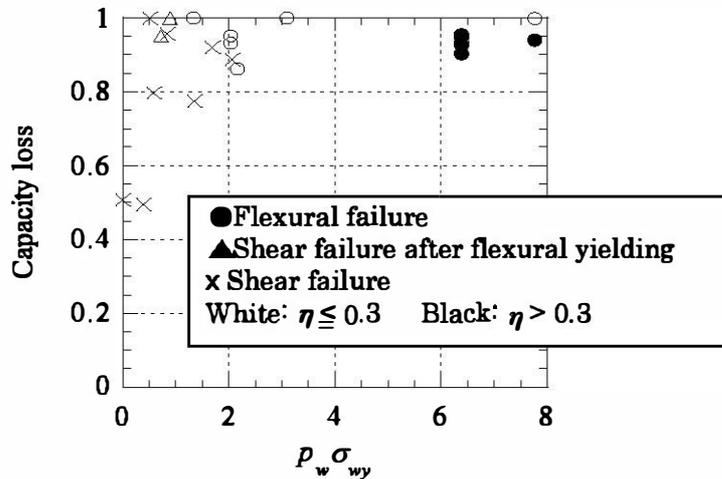
Figure 4.2: Example of relationship between shear reinforcement amount and capacity loss

The relationship between the specifications of specimens and their deformation performance was analyzed regarding specimens that underwent flexural failure or shear failure after flexural yielding among those collected in the database. Figure 4.2 shows an example of the relationship between the amount of shear reinforcement and the capacity loss ratio at a drift angle of 1/50 (corresponding to a plasticity ratio of 3 when the yielding drift angle is assumed to be 1/150) of specimens extracted from papers published from 2003 to 2008. Specimens that underwent shear failure are also plotted in the figure for comparison. Note that the capacity loss ratio is defined here as the ratio of the capacity at a drift angle to the maximum capacity.

It is not appropriate to hastily conclude, as the shear margin also depends on the axial force and tensile reinforcement ratio, but within the range presented herein, a specimen tends

to undergo flexural failure when $p_w \sigma_{wy}$ roughly exceeds 2. Similarly, it scarcely suffers a significant capacity loss at a drift angle of 1/50 when $p_w \sigma_{wy}$ exceeds 3.

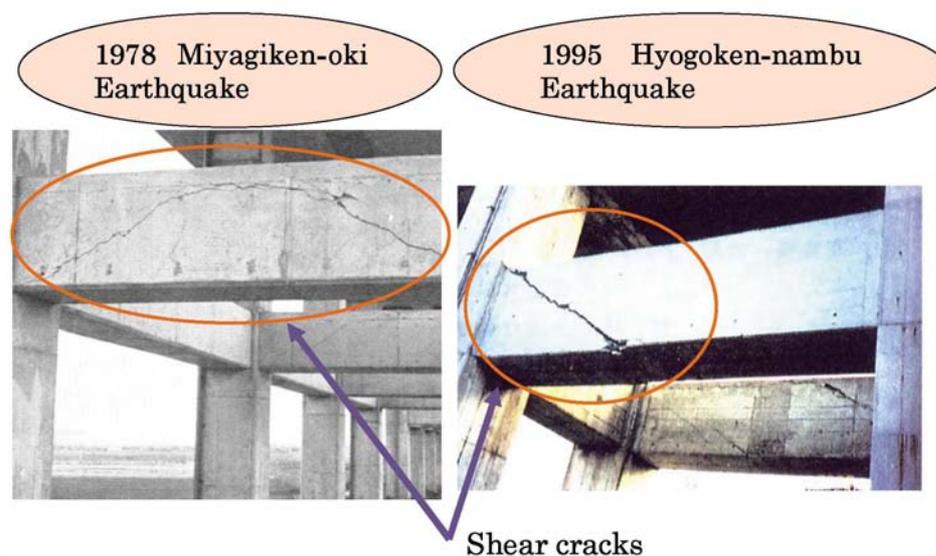
Figure 5.1: Shear failure of intermediate beams

Damage to rigid-frame viaducts during the 1978 Miyagiken-oki Earthquake and 1995 Hyogoken-nambu Earthquake included shear failure of the intermediate layers of such viaducts (Fig. 5.1). It is important to investigate its handling, as it does not directly lead to collapse of the entire structure. Shear failure of an intermediate layer increases the bending moment of columns, causing concern about large deformation of the viaduct, but also suggests its role as a safety device for the structural system, as simultaneously the natural period of the structure changes and the deformability of columns increases. The possibility of such an effect has been investigated by seismic response analysis incorporating the shear failure of intermediate beams. Active investigation should be carried out on this subject.

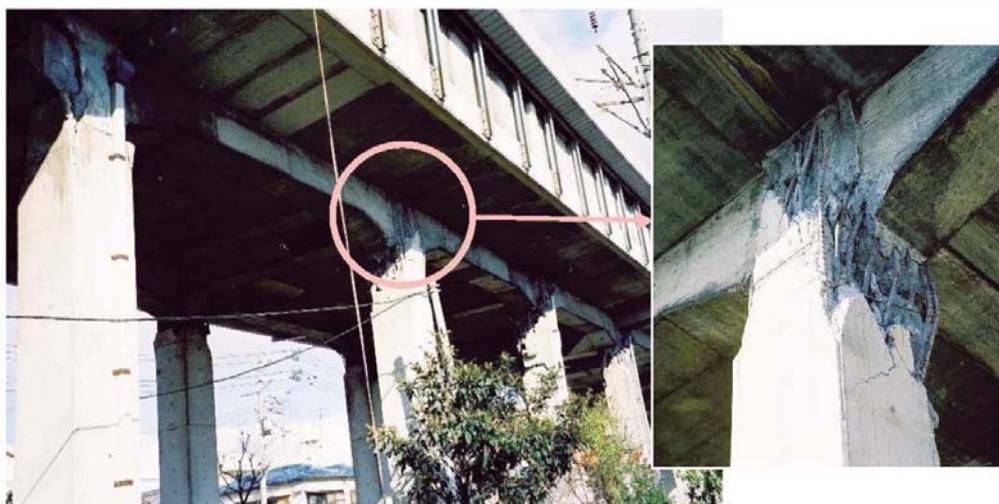
Figure 5.2: Damage to member joint

In the currently practiced design procedure, member joints are assumed to be sufficiently rigid and not subjected to damage in most cases. However, damage to joints between beams of the upper layer and columns during an earthquake have been reported (Fig. 5.2). Recent studies have revealed the possibility of damage to member joints depending on the method of anchoring longitudinal reinforcing bars and the shape of joints. The verification of member joints may therefore be required in certain cases. When damage is predicted in member joints, its effects on the entire structure should also be considered.

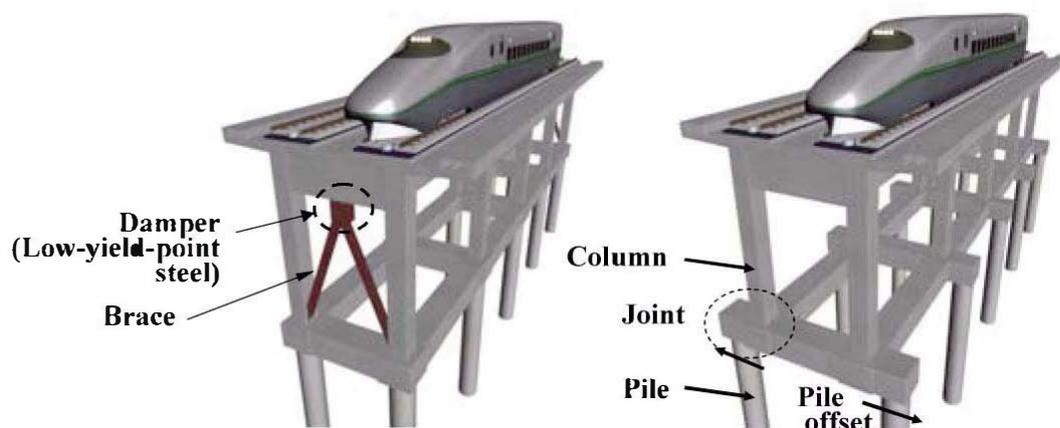
Figure 5.3: Examples of measures to protect train traffic

In view of the damage causing derailment of a Shinkansen train in service during the 2004 Niigataken-Chuetsu an earthquake are under study. Though there are limitations in ensuring train traffic solely by the structure of viaducts, it is necessary to further investigate their functional safety, which is normally most important among performance requirements for viaducts (**Fig. 5.3**).
