Technical Committee on concrete deterioration in natural environments

Abstract

This technical committee ascertained the state of concrete deterioration, organized and verified the latest environmental evaluation techniques related to the deterioration mechanism, and organized the latest testing methods. The targeted deterioration was rebar corrosion due to carbonation, salt damage, frost damage, and soil degradation, but the group also aggressively examined the state of frost damage in the Kyushu and Chugoku regions in particular, as well as discussing the external degrading forces and initiating new exposure.

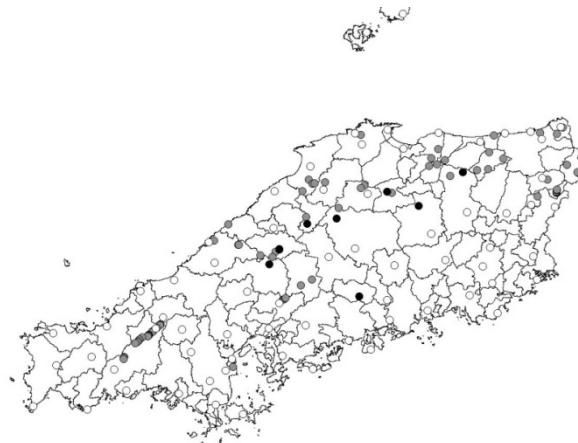
Fig. 3: Locations of frost damage risk and frost damage structures

The survey of frost damage examples in the Chugoku region covered mainly public structures, and involved requests for cooperation mainly from agencies managing those structures. Consequently, the present survey did not target buildings managed by private organizations or individuals. A questionnaire was sent to potential respondents, and then the responses were compiled. The questionnaire items were “Location (longitude, latitude),” “Structure type,” “Deformation site,” “Deformation site direction,” “Year of completion or years of service,” “Deformation determined to be frost damage,” “Images or deformation development maps,” “Water supply source or path to deformation site,” “Presumed deterioration mechanism and advancement,” “Characteristics of surrounding environment,” “Any effects from anti-freezing agents” and “Any detailed surveys (non-destructive testing or core sampling).” The survey period was August 2016 to February 2017. During that time, 77 responses were received for 91 sites. The types and numbers of structures for which responses were received were 62 bridges, 11 roads, two retaining walls, one parking garage, and one dam. The present survey was mainly of public structures with many of the responses concerning bridges. Amongst these, 60 % of all the responses concerned bridge substructures such as the vertical walls of abutments or pier beams. **Fig 3** shows the whereabouts of frost damage in the Chugoku region and frost-damaged structures obtained from the survey. Examples of frost-damaged structures were found even in regions with 0 frost damage risk.

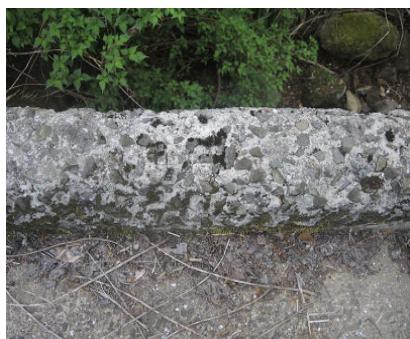
Photograph 1: Scaling in bridge wheel
guard

Many examples were seen of scaling (**Photograph 1**) and cracks, which are typical deteriorations due to frost damage. Examples were seen in which this deterioration advanced and led to rebar exposure (**Photograph 2**). Otherwise, many examples were seen of efflorescence from cracks. There were cases of oozing from the interior of cracks, and icicle-shaped deposition directly below cracks (**Photograph 3**). These continued to supply moisture to crack sites, indicating that cracks represent a pathway for water to flow, and thus present a further deterioration concern. Furthermore, there were relatively few pop-outs in the present examples (**Photograph 4**).

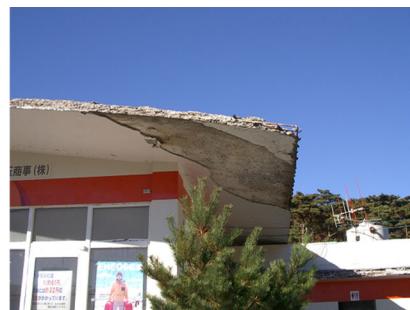
Photograph 5: Peeling-off and reinforce
ment exposure at edge of the eaves

Deterioration due to frost damage tends to occur around rooftops and near eaves, which are places that ordinarily receive a large amount of snowmelt water. Protruding areas and corners are particularly prone, as they experience large changes in temperature. Similar tendencies are seen in the present survey. Deterioration was often seen on roof slabs at the edge of the eaves (**Photograph 5**), eaves, and on parapets. Furthermore, deterioration also occurred at protrusions at the tops of the outer pillars (**Photograph 6**).

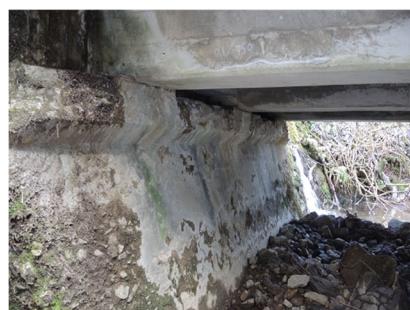
Photograph 7: Scaling in abutment

In addition, examples of prominent deterioration were also seen in places where water stagnated, or which were likely to receive water. Deterioration occurred on a north-side abutment of a bridge in a mountainous area of Fukuoka City (**Photograph 7**) that received a large amount of water from the rear. In the photograph, significant deterioration was seen in places directly struck by water drops dripping from overhangs on the top of the abutment.

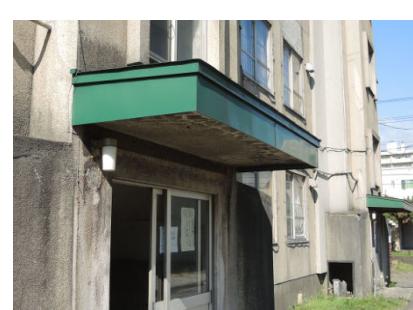
Photograph 9: Example of measures for eaves
(Muroran)

In addition, frost damage in Kyushu is characterized by concrete eaves (**Photograph 9**), which are not seen much in Hokkaido (although the example is from Muroran), and a lack of consideration in design for such factors as pooling water.

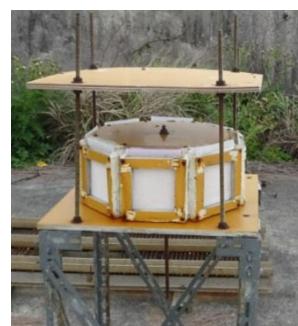
Photograph 11: Eight-direction dry gauze collector

dried gauze¹³⁾. A summary of this is shown in **Fig.7**.

Fine salt particles drifting in the air might not adhere to the surface of a stainless-steel plate in a PWRI-type airborne choride ion collector. However, it is predicted that with the dry gauze method, in contrast to the PWRI-type collector, chloride with large particles, as in sea spray, cannot be caught. In addition, rainfall and snowfall adheres to the collecting surfaces of both, and thus it may not be possible to prevent this effect.

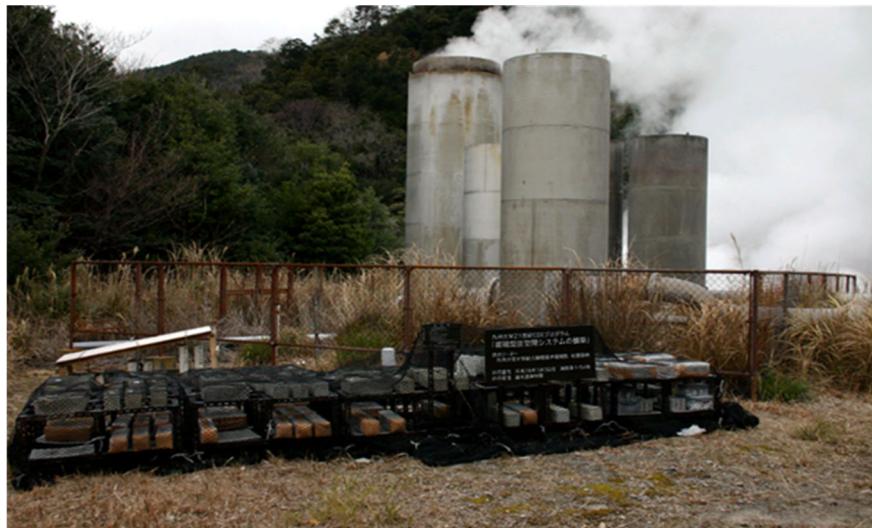
**Photograph 13: Exposure experiment in Kirishima volcanic zone
(underground laying in back soil)**

As described above, there is a wide distribution of strong acidic soil in volcano and hot spring zones in Kyushu. Civil engineering structures that come into contact with these zones, such as the Oita Expressway that traverses Kyushu, had careful surveys and experiments conducted prior to any work²³⁾. The hot springs in Tsukahara and Myoban are strongly acidic, approximately pH 1 to 2 and pH 2 to 3 respectively, and the surrounding soil is also strongly acidic. In general, it has been shown that measures for the densification of concrete in strong acidic environments, such as lowering the water-cement ratio, have tended to have the opposite effect²⁴⁾²⁵⁾. In the same work

project, measures were undertaken such as increasing the concrete thickness, adding corrosion-resistant lining to surfaces, and providing alkaline soil treatment²⁶⁾. In recent years, bridges in the Kirishima volcanic zone have been built with concrete using shirasu as fine aggregate for a strong acid measure, which has proven effective²⁷⁾.
