Repair and strengthening of bridge decks using UHPFRC

Central Nippon Expressway Company Limited
(NEXCO Central)

Outline

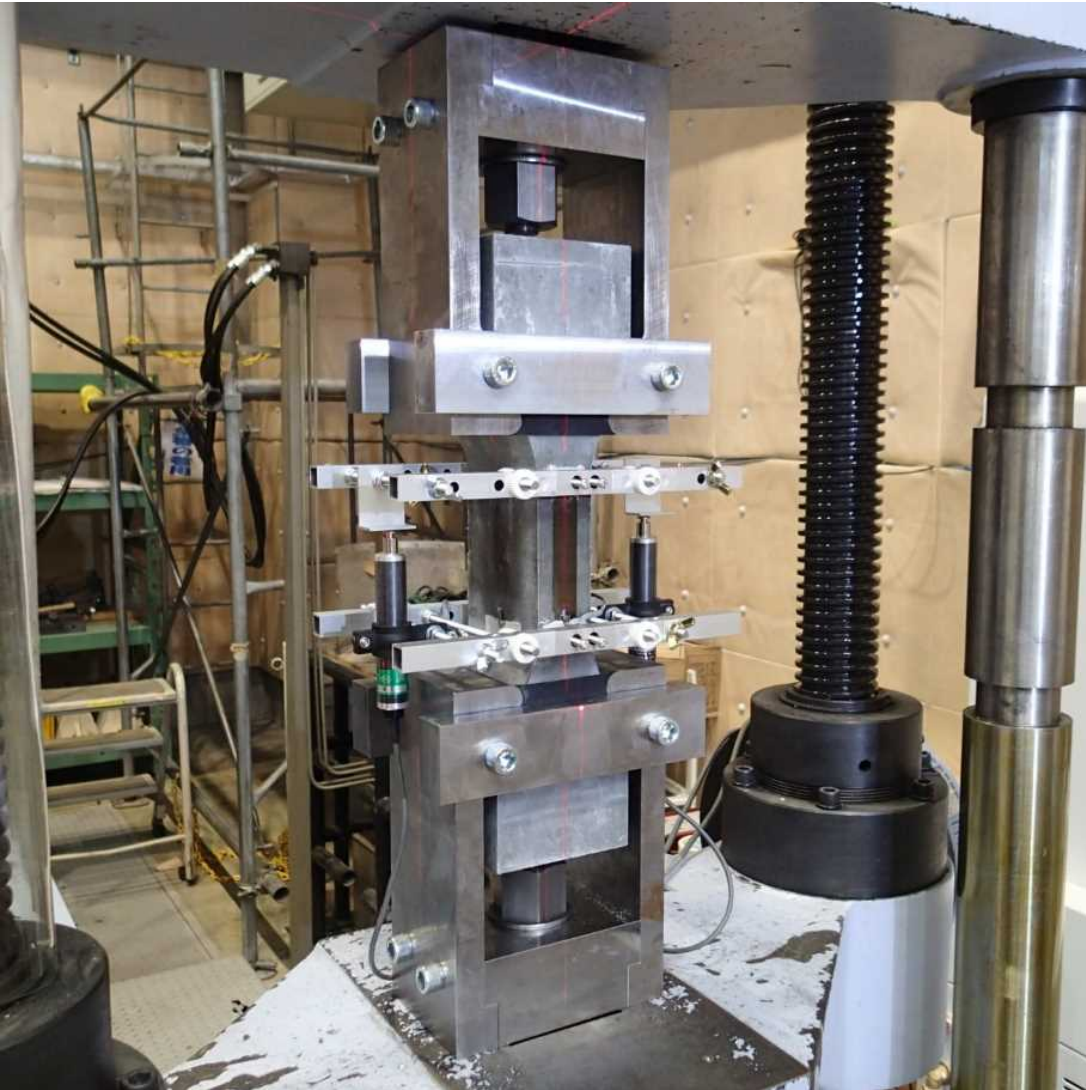
Direct tension tests of UHPFRC

- ✓ Understand the strain hardening behavior achieved by increasing the fiber content to 3.0 vol.-%
- ✓ Understand the tensile property of the UHPFRC cured at normal temperature (w/o heat curing)

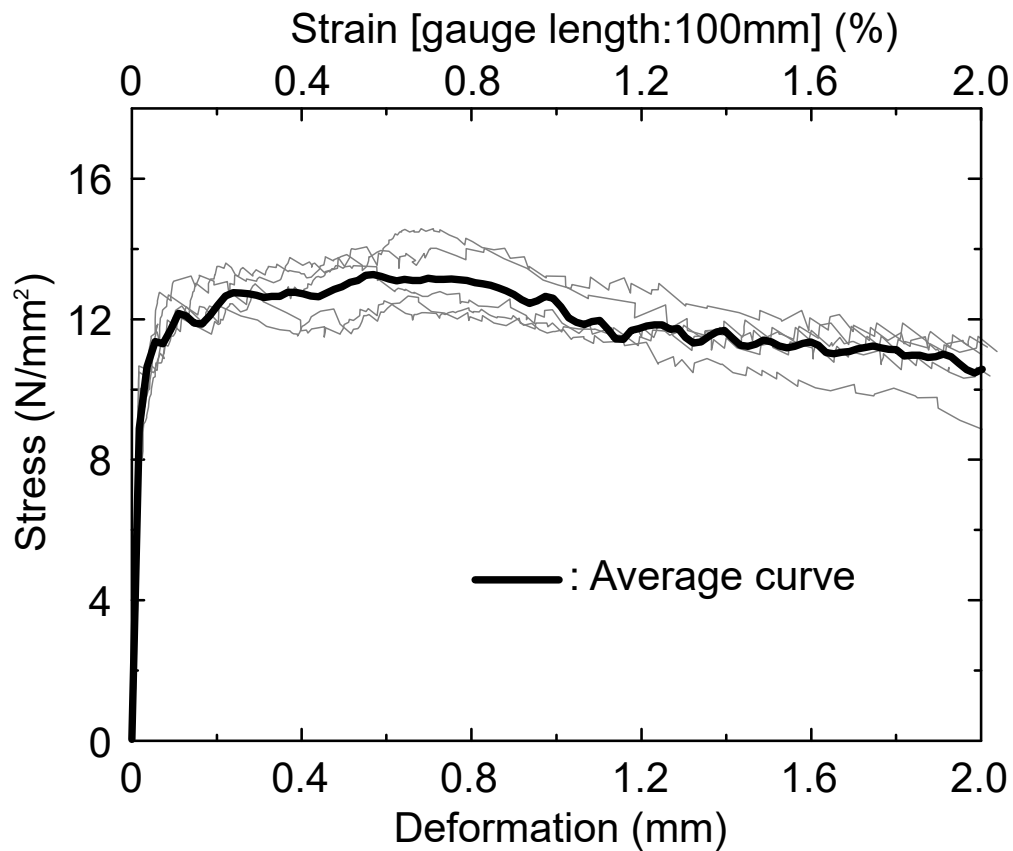
1.75 vol.-% ($l = 15$ and 22 mm, $d = 0.2$ mm)
20°C - 24hrs → 85°C - 24hrs

- ✓ [1.75 vol.-%] moderate decrease in stress in the softening domain because the 22mm long fibers delayed the increase in crack width
- ✓ [3.0 vol.-%] higher cracking strength and larger strain hardening due to its higher fiber volume fraction

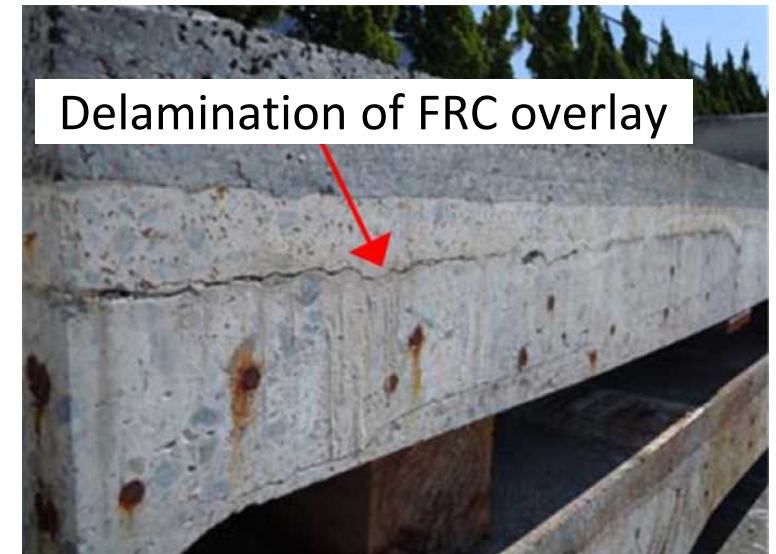
- ✓ Focus on the adhesive at the interface (Is it necessary or not?)
- ✓ Tensile bond strength tests using composite cylinder specimens ($\phi 100\text{mm}$, $50\text{mm}+50\text{mm}$)
- ✓ Shear bond strength tests using composite cube specimens ($100 \times 100\text{mm}$, $50\text{mm}+50\text{mm}$)

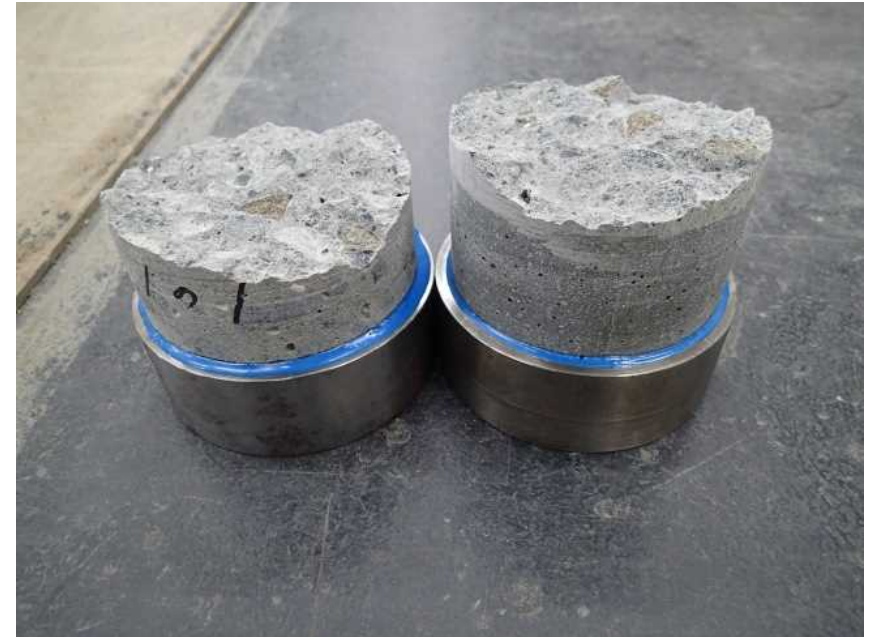
Results of tensile bond strength tests

Specimen	No.	Tensile bond strength (N/mm ²)
w/o epoxy adhesive	1	2.31
	2	2.20
	3	2.45
	Average	2.32
w/ epoxy adhesive	1	2.79
	2	3.14
	3	2.84
	Average	2.92

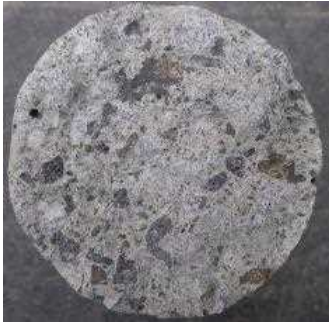
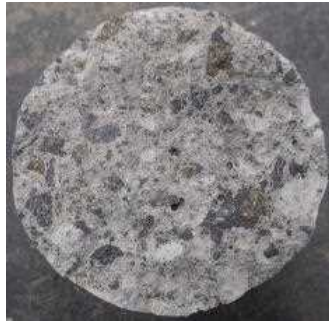
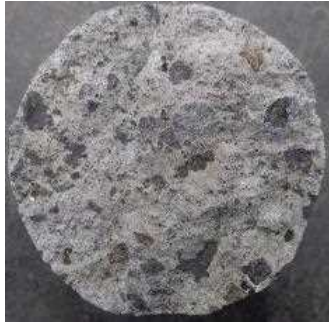
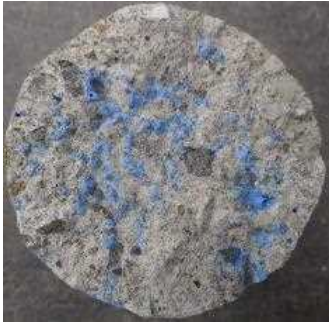
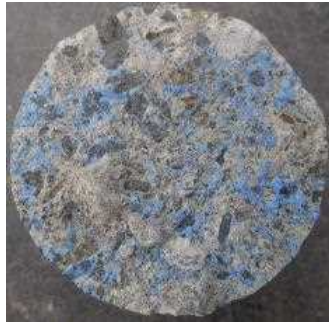
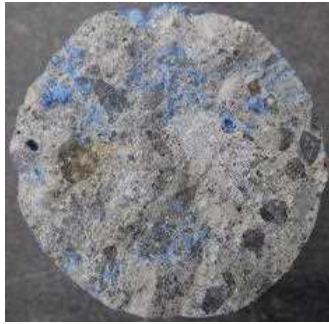
Specimen	1	2	3
w/o epoxy adhesive

w/ epoxy adhesive

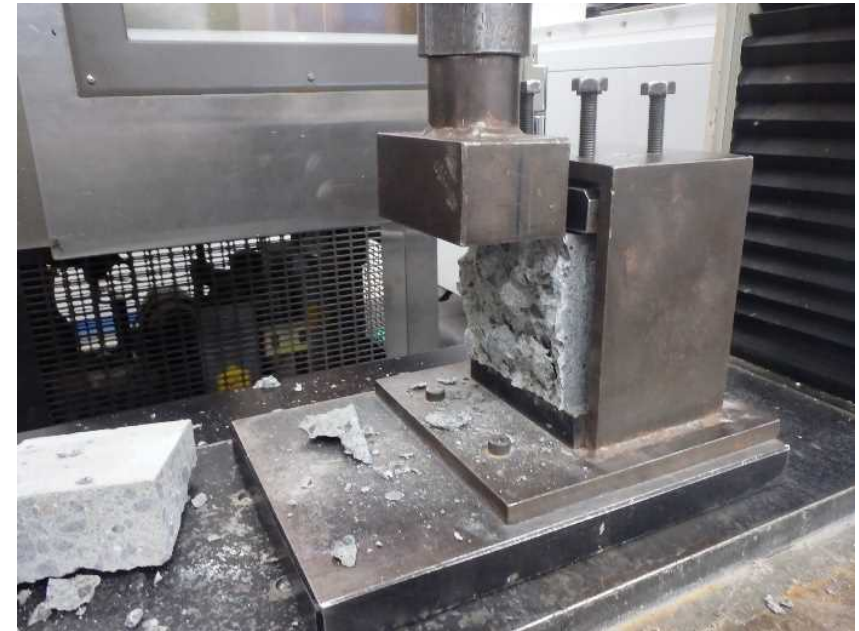
Results of shear bond strength tests

Specimen	No.	Shear bond strength (N/mm ²)
w/o epoxy adhesive	1	4.17
	2	6.28
	3	5.64
	Average	5.36
w/ epoxy adhesive	1	3.34
	2	4.81
	3	4.60
	Average	4.25

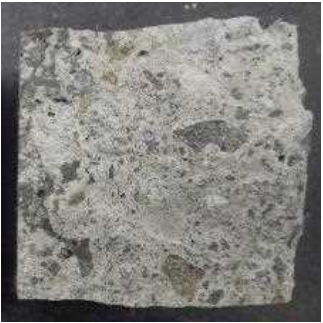
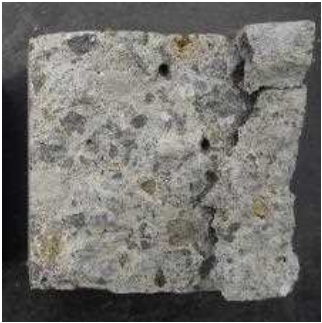
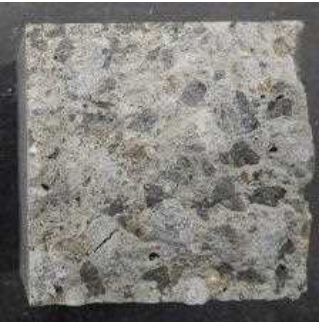
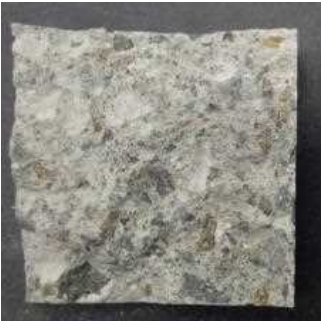
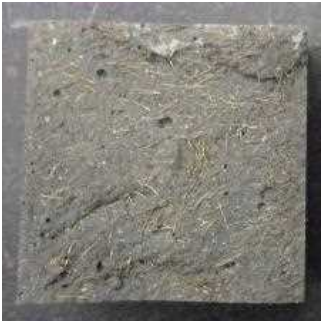
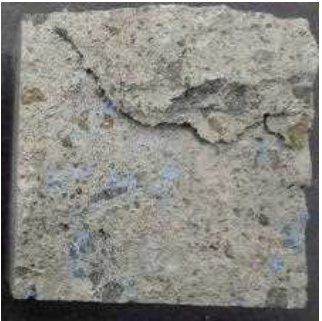
Specimen	1	2	3
w/o epoxy adhesive

w/ epoxy adhesive

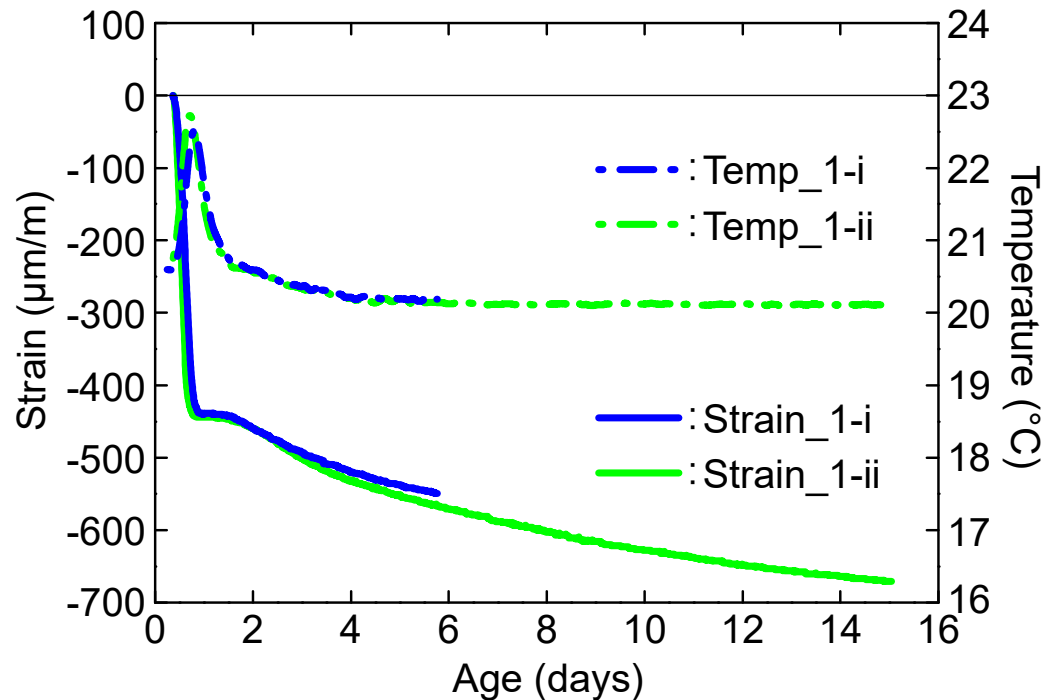
Free strain and specimen temperature

- ✓ Restraint condition : full restraint
- ✓ Temperature : 20°C
- ✓ Test duration : six days and fifteen days

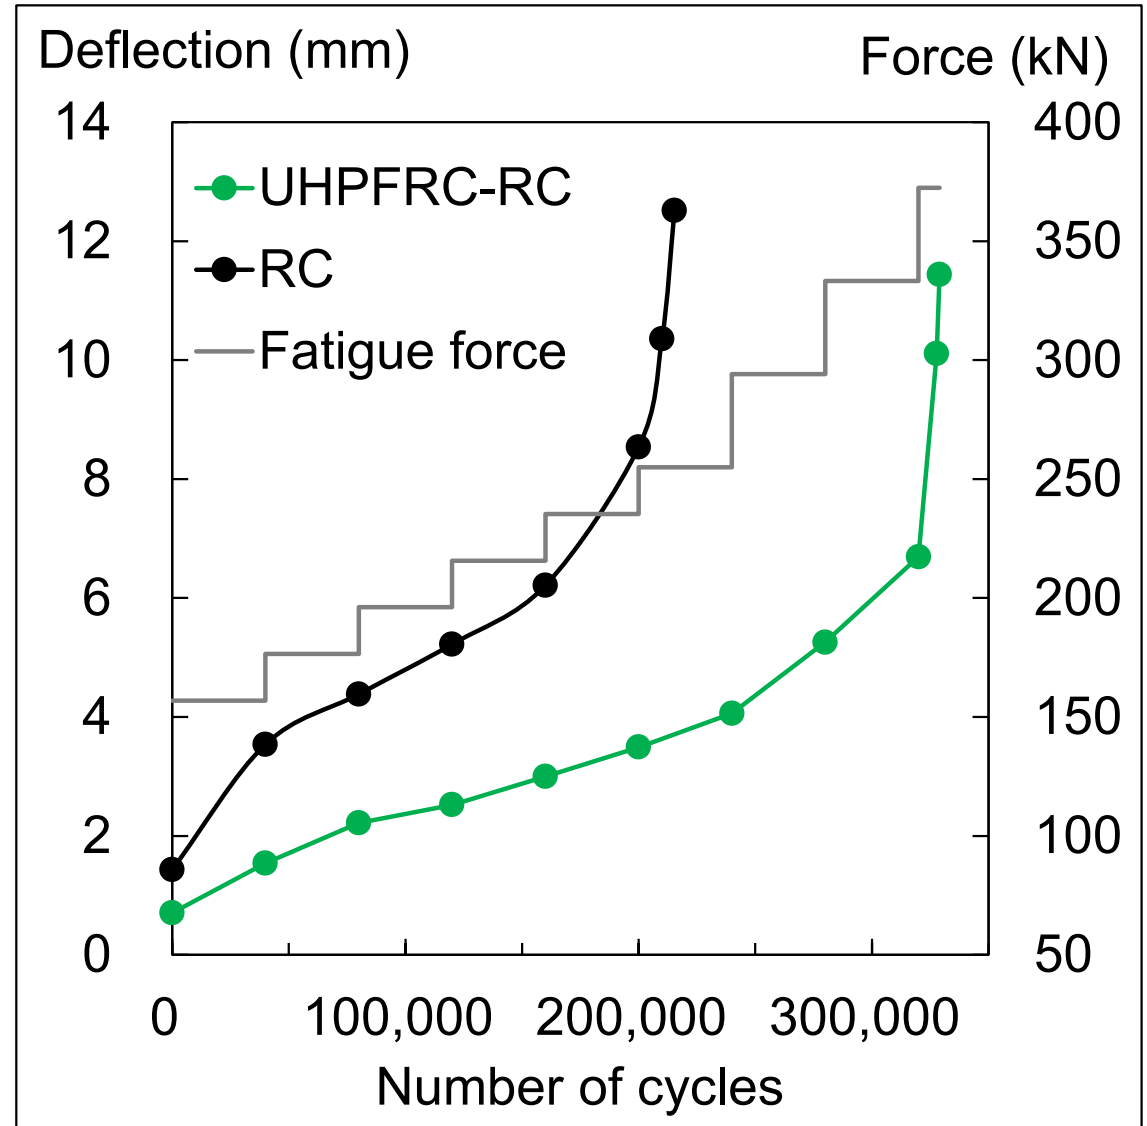
Stepwise increasing fatigue loading and deflection growth

Step	Load (kN)	Number of cycles
1	156.9	40,000
2	176.5	40,000
3	196.1	40,000
4	215.7	40,000
5	235.3	40,000
6	254.9	40,000
7	294.1	40,000
8	333.3	40,000
9	372.5	9000
	Failed	329,000

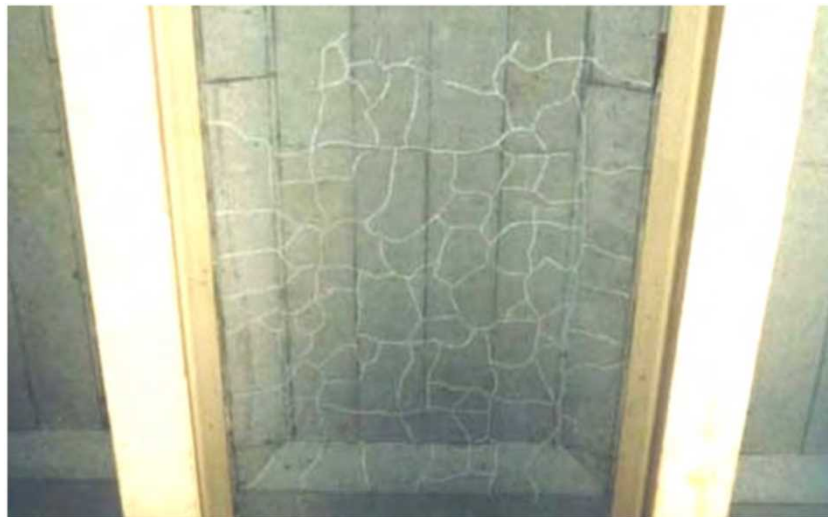
Bottom surface of a fatigue damaged RC bridge deck

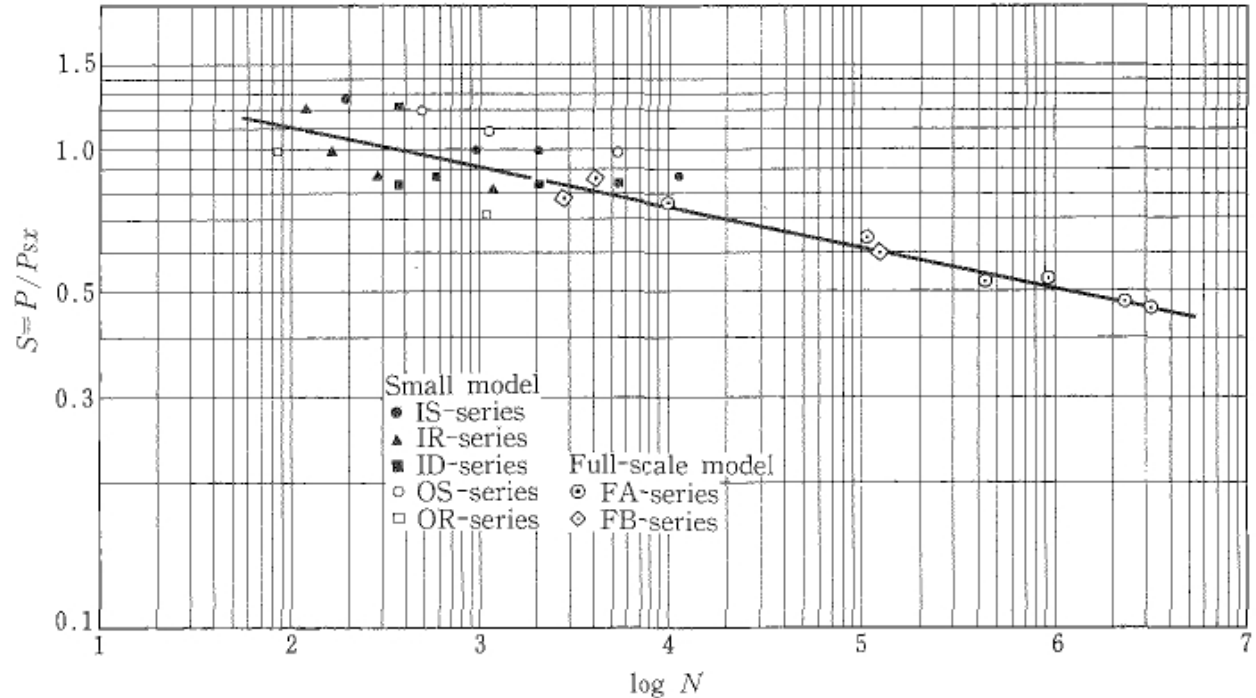
S-N relationship for RC deck slabs

30 mm thick UHPFRC overlay increases the fatigue life of RC decks by about five times.

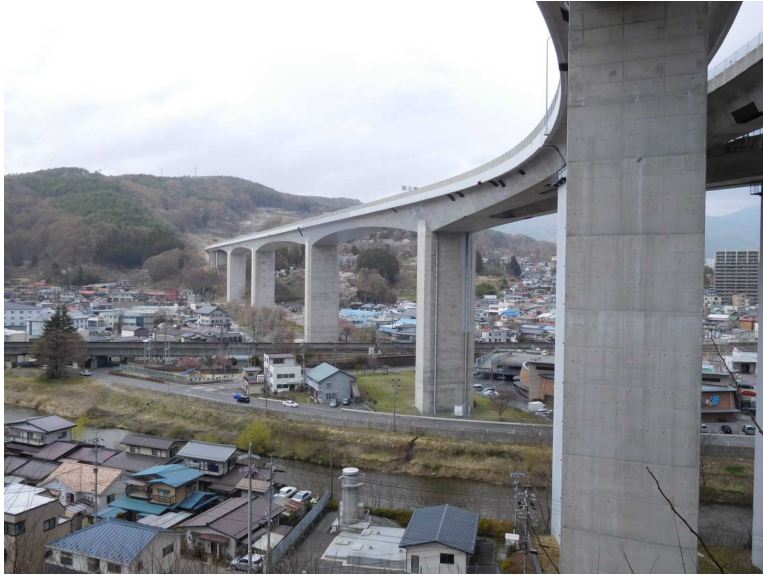
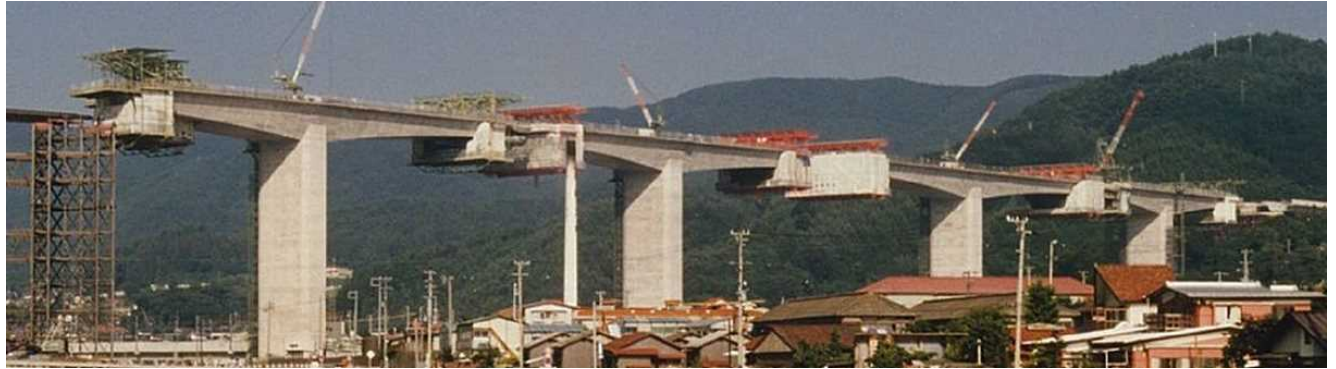
Repair of Okaya Viaduct using UHPFRC

- ❑ Located in Okaya, Nagano Prefecture, and opened in 1986
- ❑ Five span post-tensioned box girder bridge (L = 593m, 102+126+148+126+87.88m)
- ❑ Balanced cantilever construction method

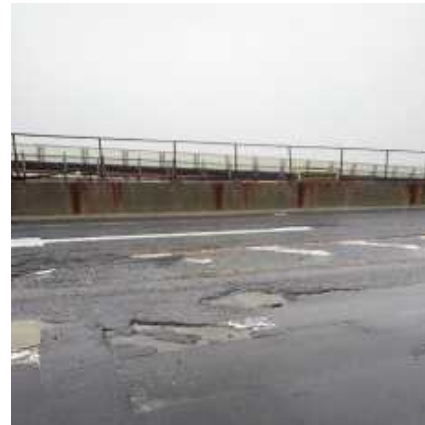
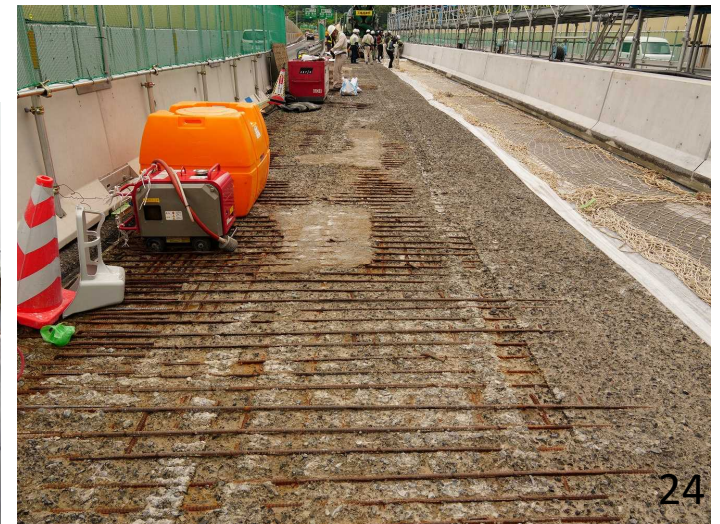
Causes of deck deterioration

- ✓ No waterproofing applied to the top surface of the deck
- ✓ Insufficient concrete cover thickness
- ✓ Poor quality concrete used for anchorage pour backs

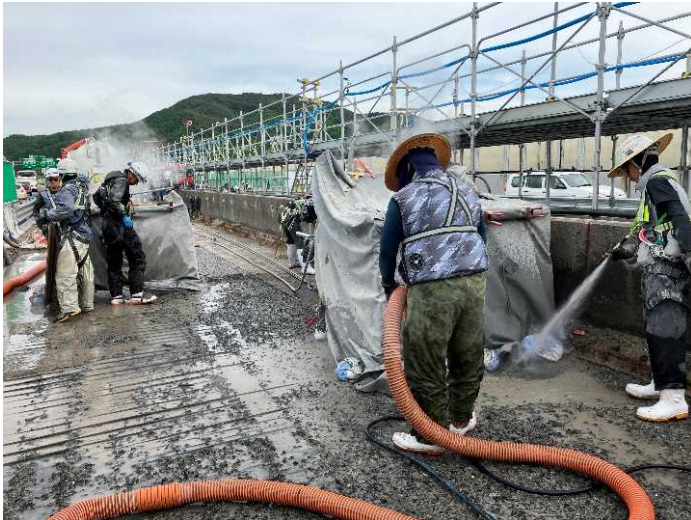
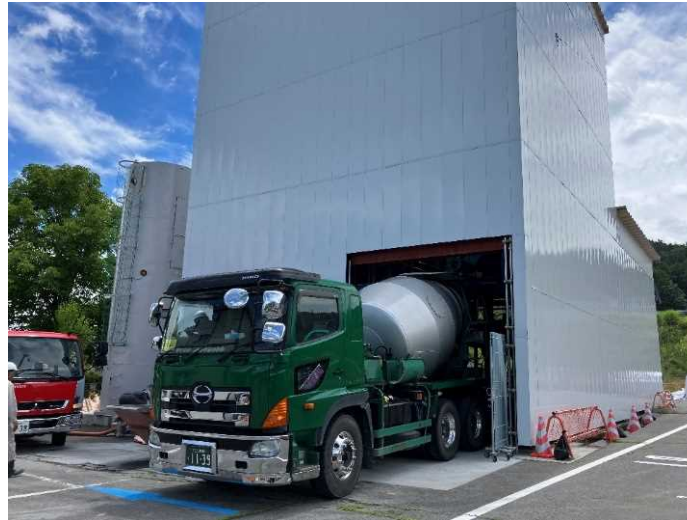
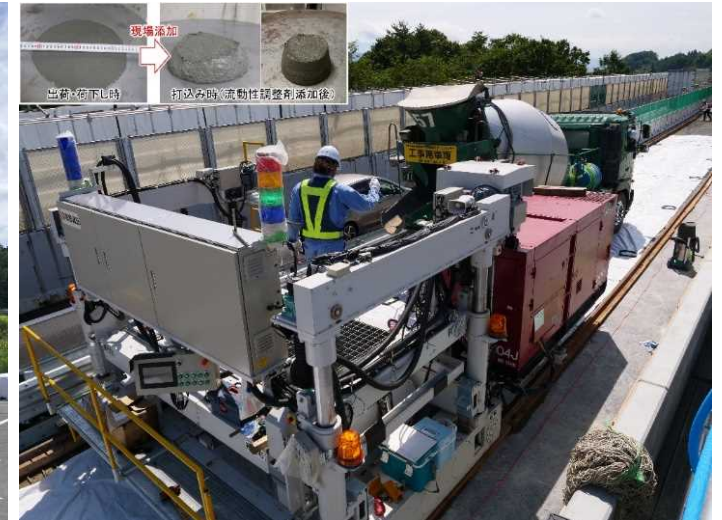
UHPFRC overlay construction process

Transport UHPFRC from a temporary batching plant

Transport within the site

Place and spread

Finish and cure
