Rehabilitation and Preservation of Extremely Damaged World Heritage Concrete Structures

Takafumi NOGUCHI
Professor, The University of Tokyo

7TH JCI-ACI JOINT SEMINAR 2025: INNOVATIONS AND NEW DEVELOPMENTS IN CONCRETE STRUCTURES

Hashima Island

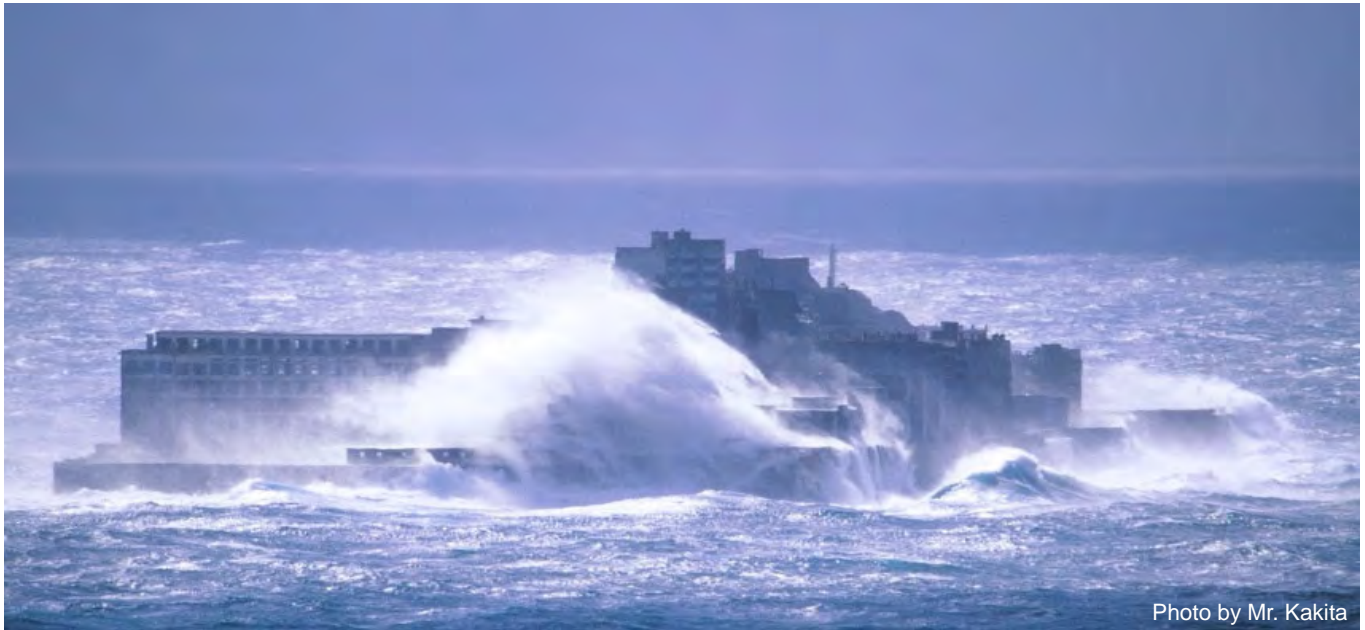
Chloride attack in typhoon season

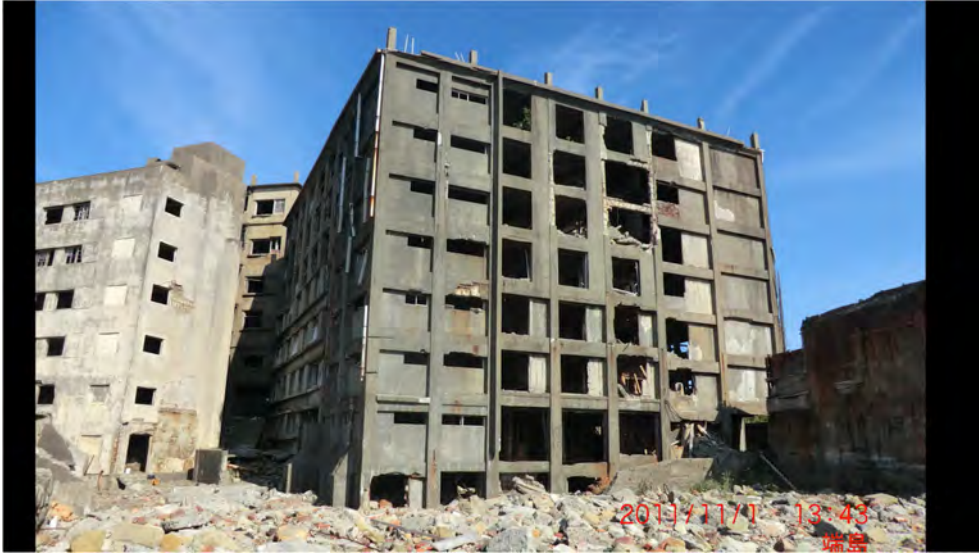
Outdoor change of No.30 building (1916)

March 2020

Rooftop slab/wall collapse on south side

June 2020

Rooftop slab/wall collapse on west side

November 2021 - June 2023

South rooftop slab collapse (different location)

October 2024 - November 2024

East rooftop slab collapse

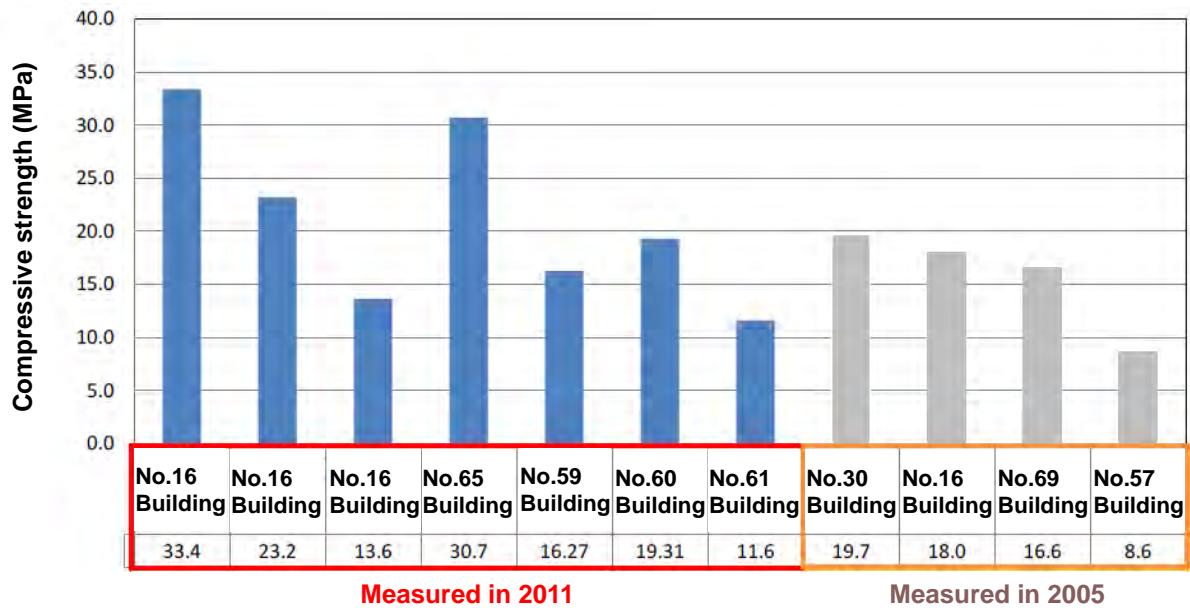
Compressive strength of concrete

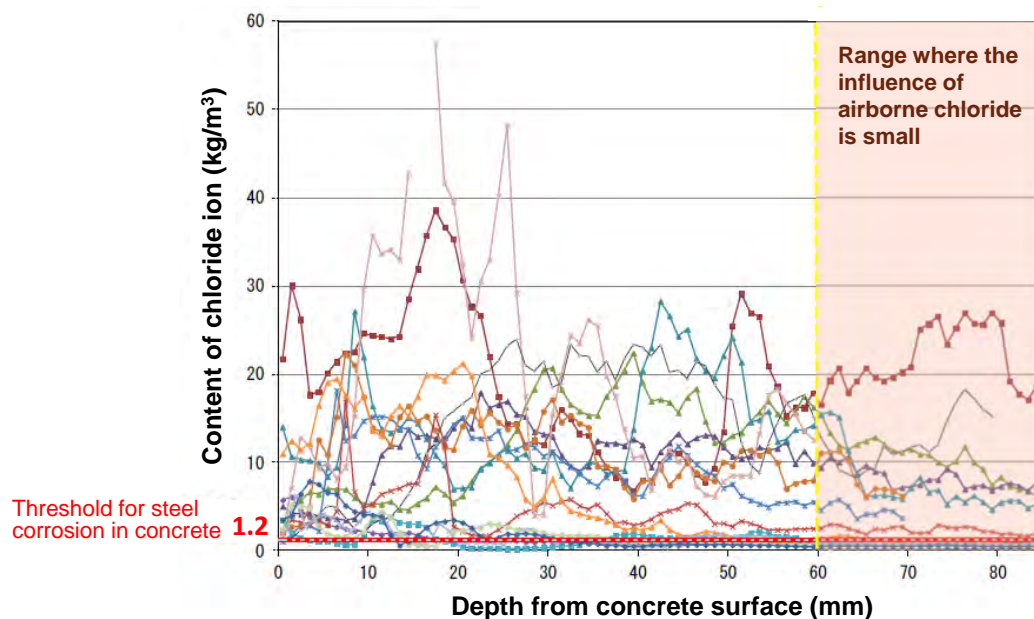
Chloride ion content

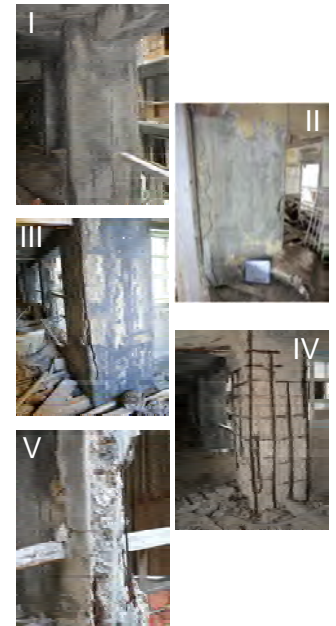
Classification of members based on deterioration level

Grade	Deterioration state	
I	Concrete	No crack, or minor cracks not due to rebar corrosion
	Rebars	No corrosion, or minor corrosion (3% or less mass reduction)
II	Concrete	Cracks, rust stain and partial spalling due to rebar corrosion
	Rebars	Clearly corroded (3 to 10% mass reduction), and bonding to concrete slightly reduced
III	Concrete	Partial spalling or completely separation from rebars due to rebar corrosion
	Rebars	Advanced corrosion (about 10% mass reduction)
IV	Concrete	Cover concrete continuous spalling, and rebars largely exposed
	Rebars	Significant corrosion (10 to 30% mass reduction), but no breakage
V	Concrete	Cover concrete totally spalled off and concrete behind rebars also damaged
	Rebars	Terrible corrosion (30% or more mass reduction) or broken

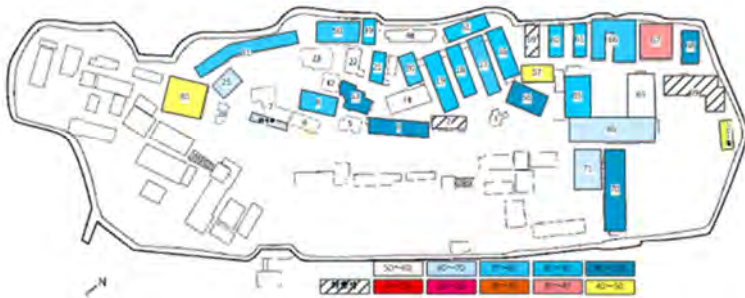
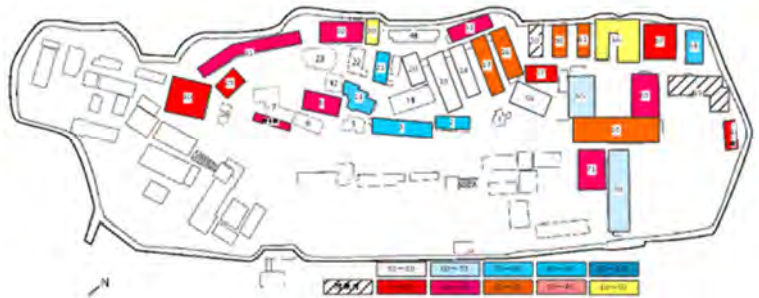
Residual structural performance of buildings

Residual capacity of vertical load

Residual seismic resistance

- In all buildings, the decrease in vertical load carrying capacity is relatively small.
- Some buildings have a large decrease in seismic resistance.

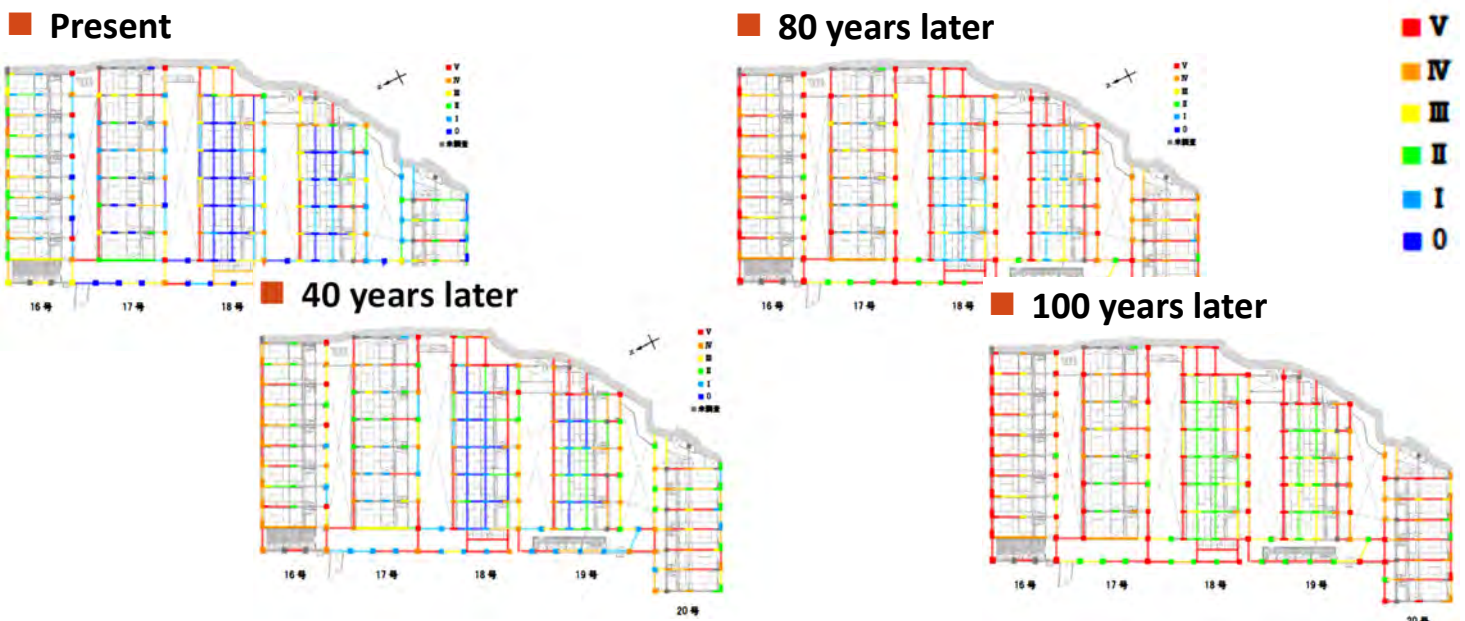
Change in degree of deterioration (Nos. 16-20 Buildings)

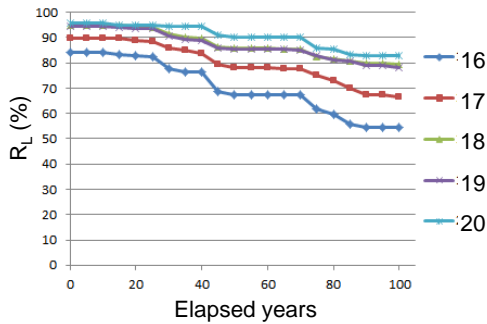
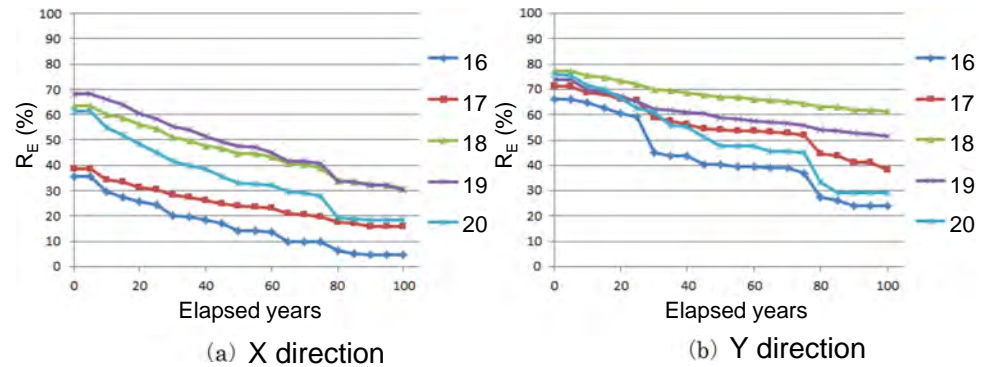
Change in residual structural performance (Nos. 16-20 Buildings)

Residual capacity of vertical load

Residual seismic resistance

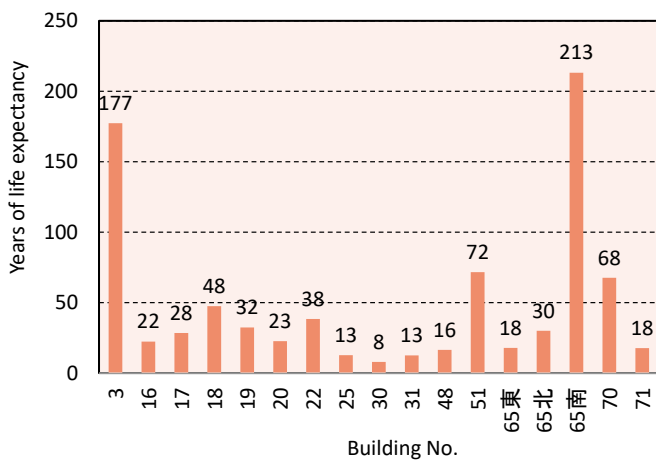
Years of life expectancy (starting in September 2015)

- Buildings collapse only by earthquakes
- Assume 100,000 buildings of the same performance
- Calculate the probability $\alpha_t(R_E)$ that a building will collapse over time
- Calculate the number of buildings remaining from the collapse probability $\alpha_t(R_E)$ at each year
- The total number remaining divided by 100,000 buildings is the life

- P (bearing capacity < seismic force) = Probability of collapse
- How many out of 100,000 buildings will collapse and when?
- The average value is the life expectancy

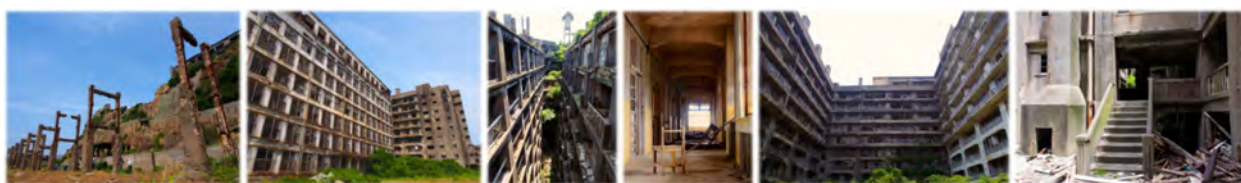
Visibility

- Visually recognized by tourists
 - The whole members
 - Part of the member
- Visually unrecognized by tourists

Repair method and appearance change according to recovery level

Grade	Target	Recovery level		
		Suppression of deterioration	Stop of deterioration	Restoration
I	Concrete	Crack filling or impregnation	Crack filling or impregnation	Crack filling
	Rebars	Impregnation (Lithium nitrite)	Desalination or electrolytic protection	Electrolytic protection
II III	Concrete	Crack filling and concrete restoration	Crack filling and concrete restoration	Crack filling and concrete restoration
	Rebars	Electrolytic protection	Electrolytic protection	Electrolytic protection
IV V	Concrete	Concrete restoration	Concrete restoration	Concrete restoration
	Rebars	Retrofitting (Additional rebars)	Retrofitting (Additional rebars)	Retrofitting (Additional rebars)

Repair method	Appearance change
Crack filling	Small
Impregnation	No
Concrete restoration	Large
desalination	No
Electrolytic protection	No to large
Retrofitting (Additional rebars)	Large

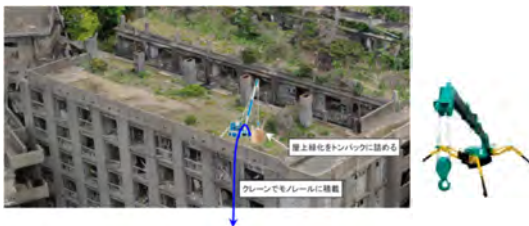
Rubble removal work and scaffolding installation work for No.16 Building

1) Carrying out rooftop greenery

2) Removal of rubble from the courtyard

3) Installation of scaffolding

4) Removal of rubble from the room

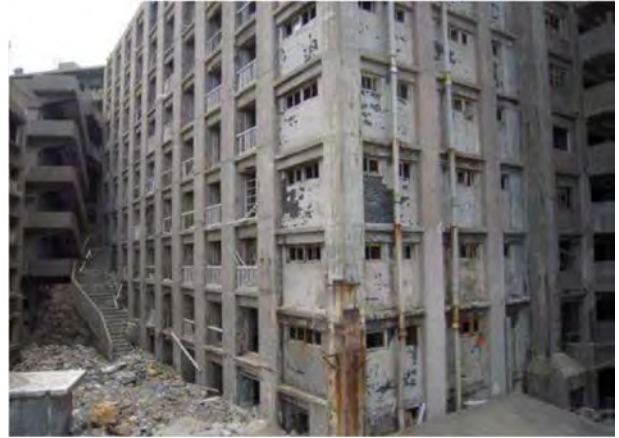
Structural performance of No.16 Building

Vertical load carrying capacity	Seismic resistance	
	X-direction (long)	Y-direction (short)
73%	24%	30%
